Appendix 1: Planning Context

DRAFT ADDENDUM to the Coastal Zone Management Study for the Richmond River Estuary

For Richmond River County Council

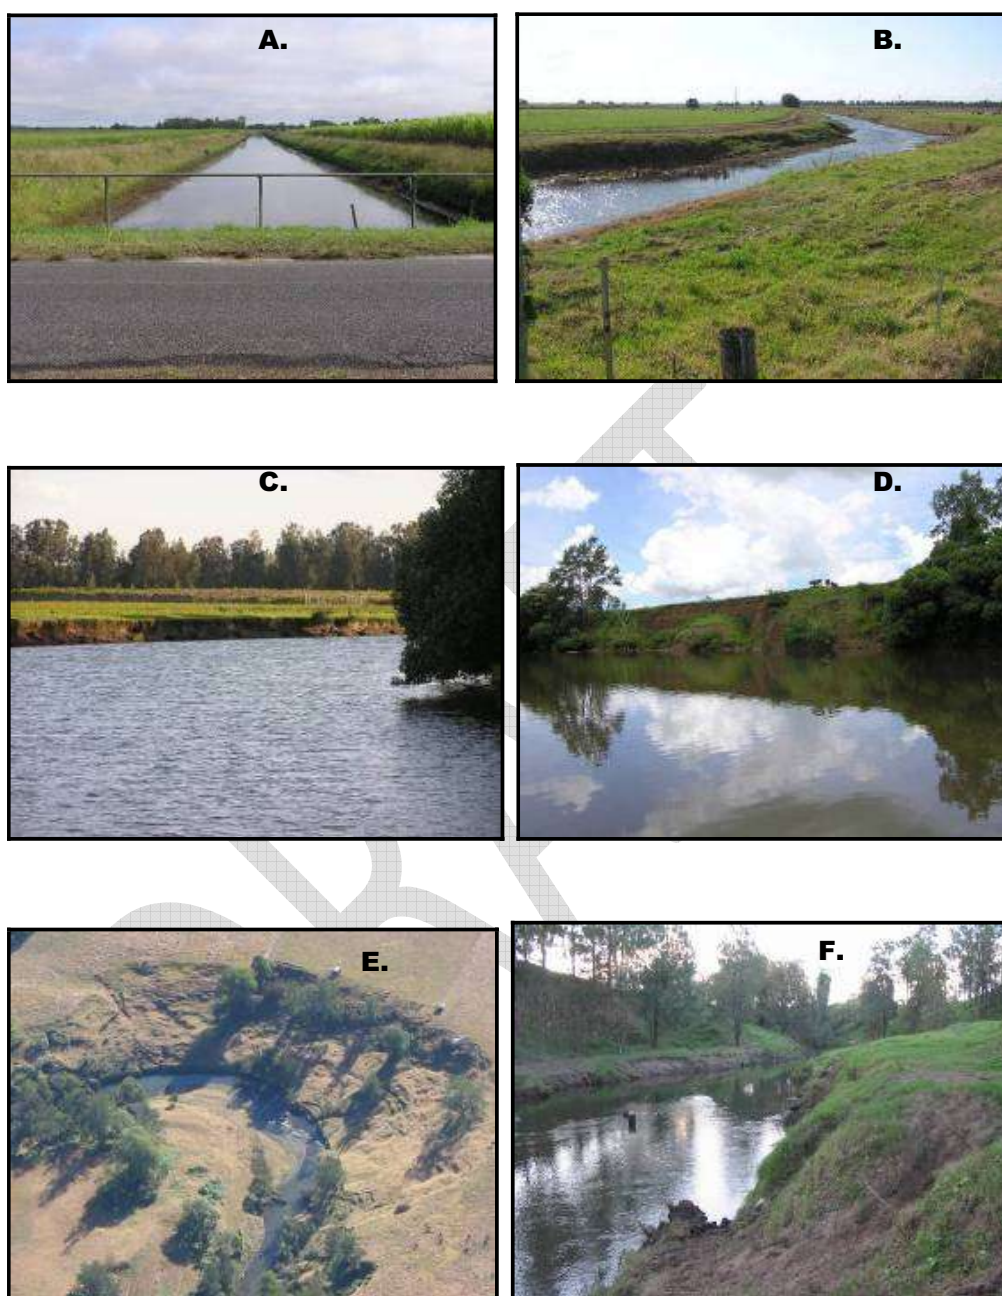
Figure 3.1. Examples of major geomorphologic issues in the Richmond River Floodplain.

A. Drainage modification for agriculture (Management Zone 9).

B. Drainage modification with steep sided banks (Management Zone 11).

C, D, E and F. Examples of bank slumping and erosion caused from removal of riparian vegetation (Management Zone 12).

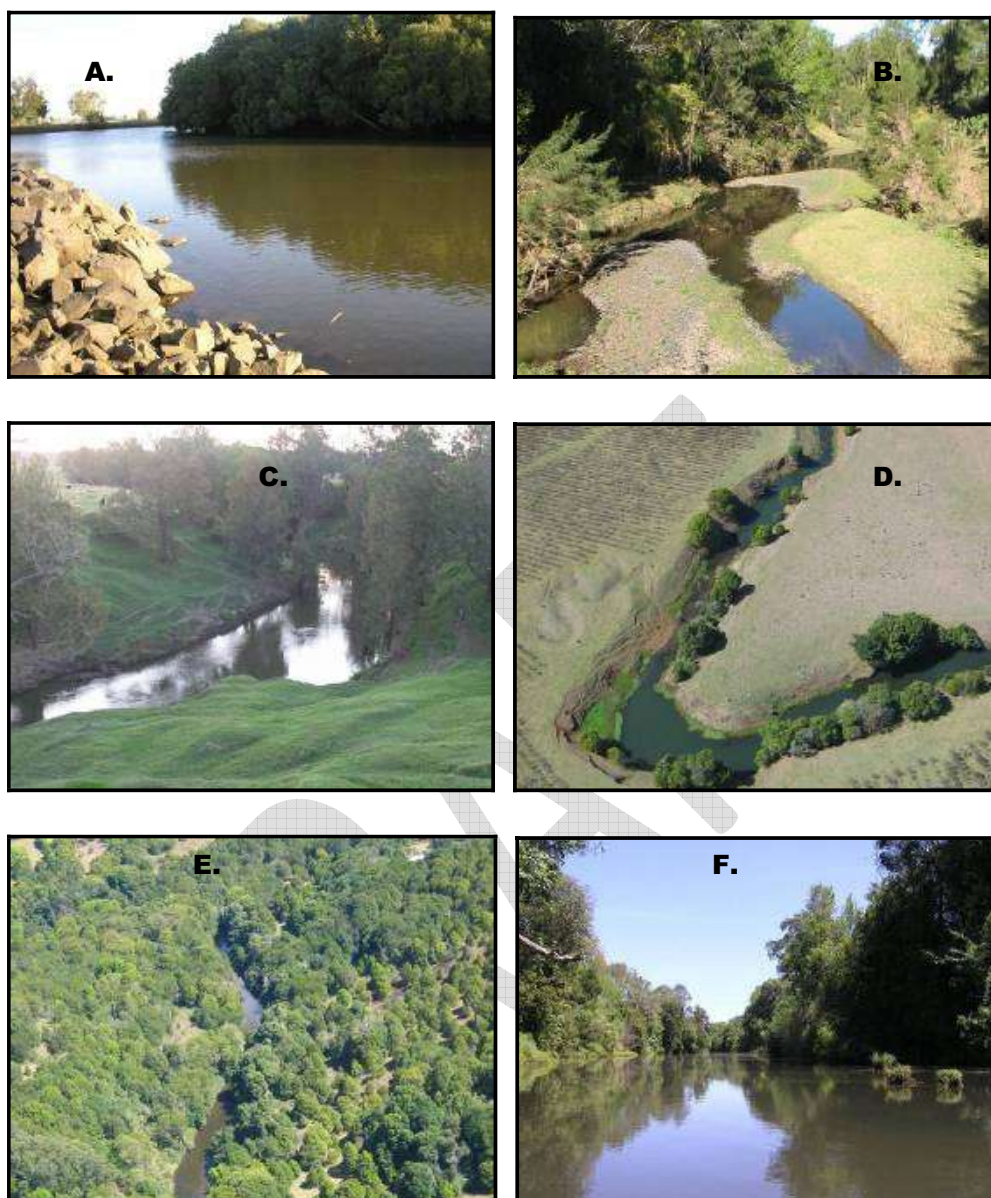
Figure 3.2 Examples of major geomorphologic issues in the Richmond River Floodplain.

- A. Loose rock bank protection (Management Zone 1).
- B. In channel sediment build up.
- C. Cattle access to watercourse.
- D. Denuded section of bank and encroaching agriculture.
- E. Stream section with healthy riparian vegetation.
- F. River section with healthy riparian vegetation.

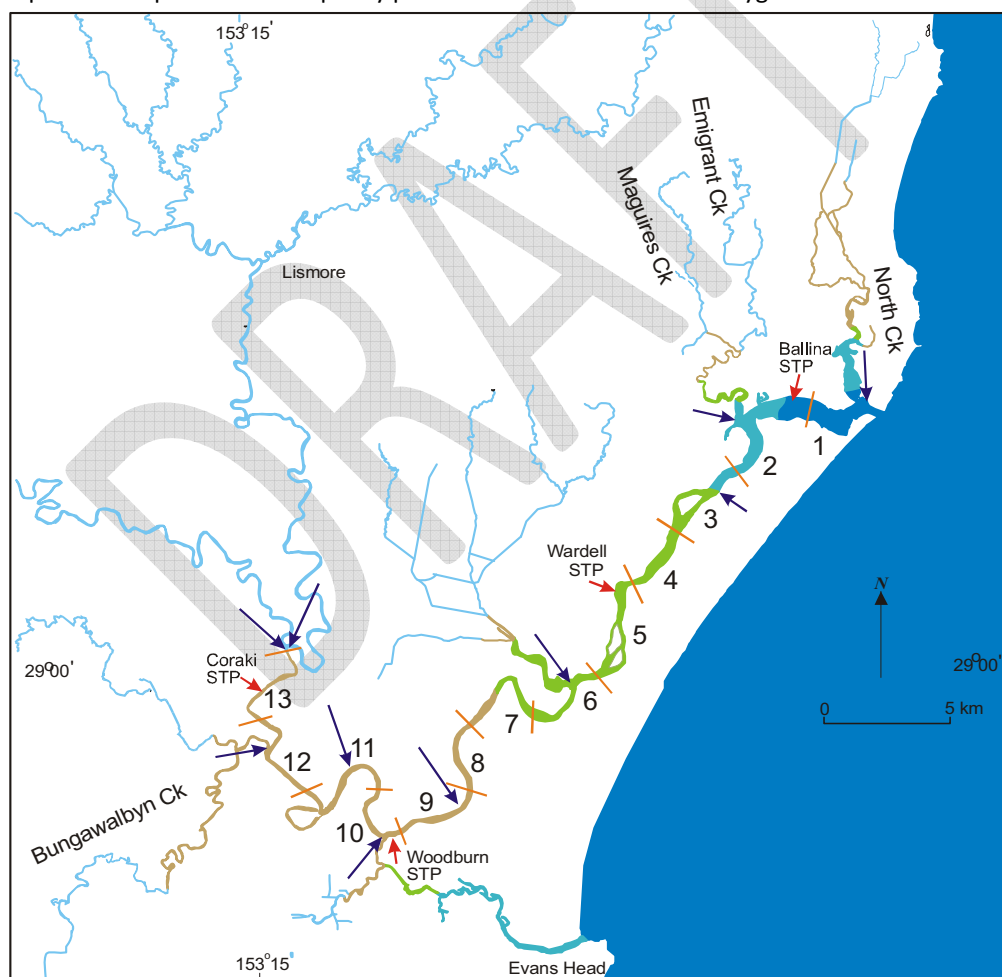
Figure 4.1; The location of box boundaries in the Richmond River Estuary Ecosystem Response Model (ERM), showing inputs of freshwater (blue arrows) and STP effluent inputs (red arrows).

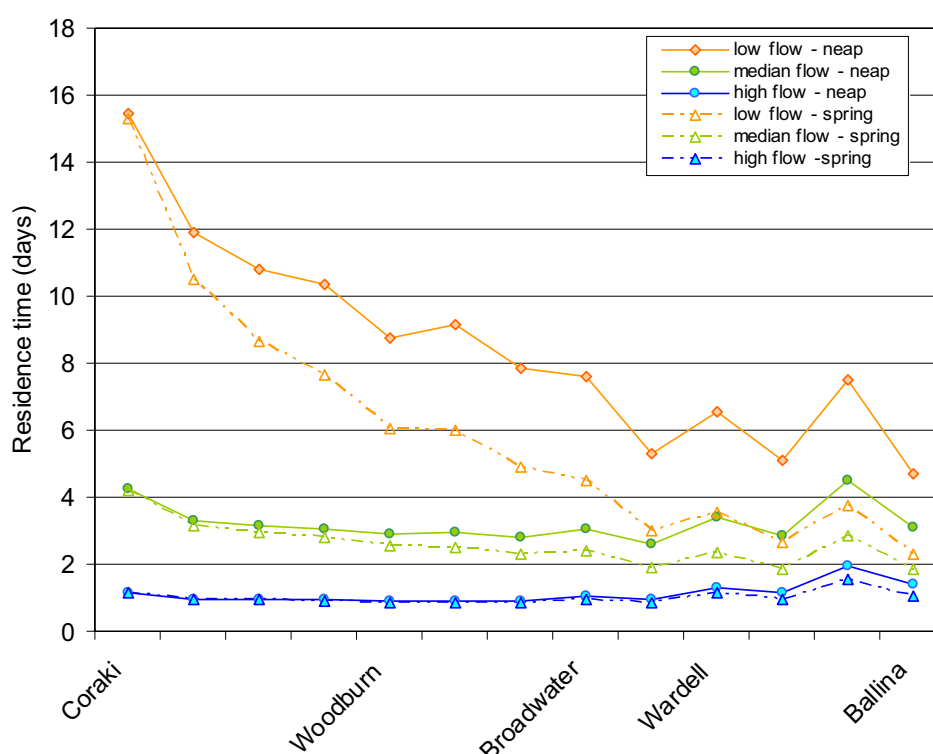
Figure 4.2 ERM estimations of water residence times in each of the 13 boxes along the Richmond River estuary for mean low flow, median and mean high flow conditions during neap and spring tides.

(neap = a less than average tide occurring at the first and third quarters of the moon)

1. morphology and depth
2. freshwater inflows
3. tidal mixing
4. water residence times (eg Figure 4.2)
5. nutrient and TSS inputs
6. light climate

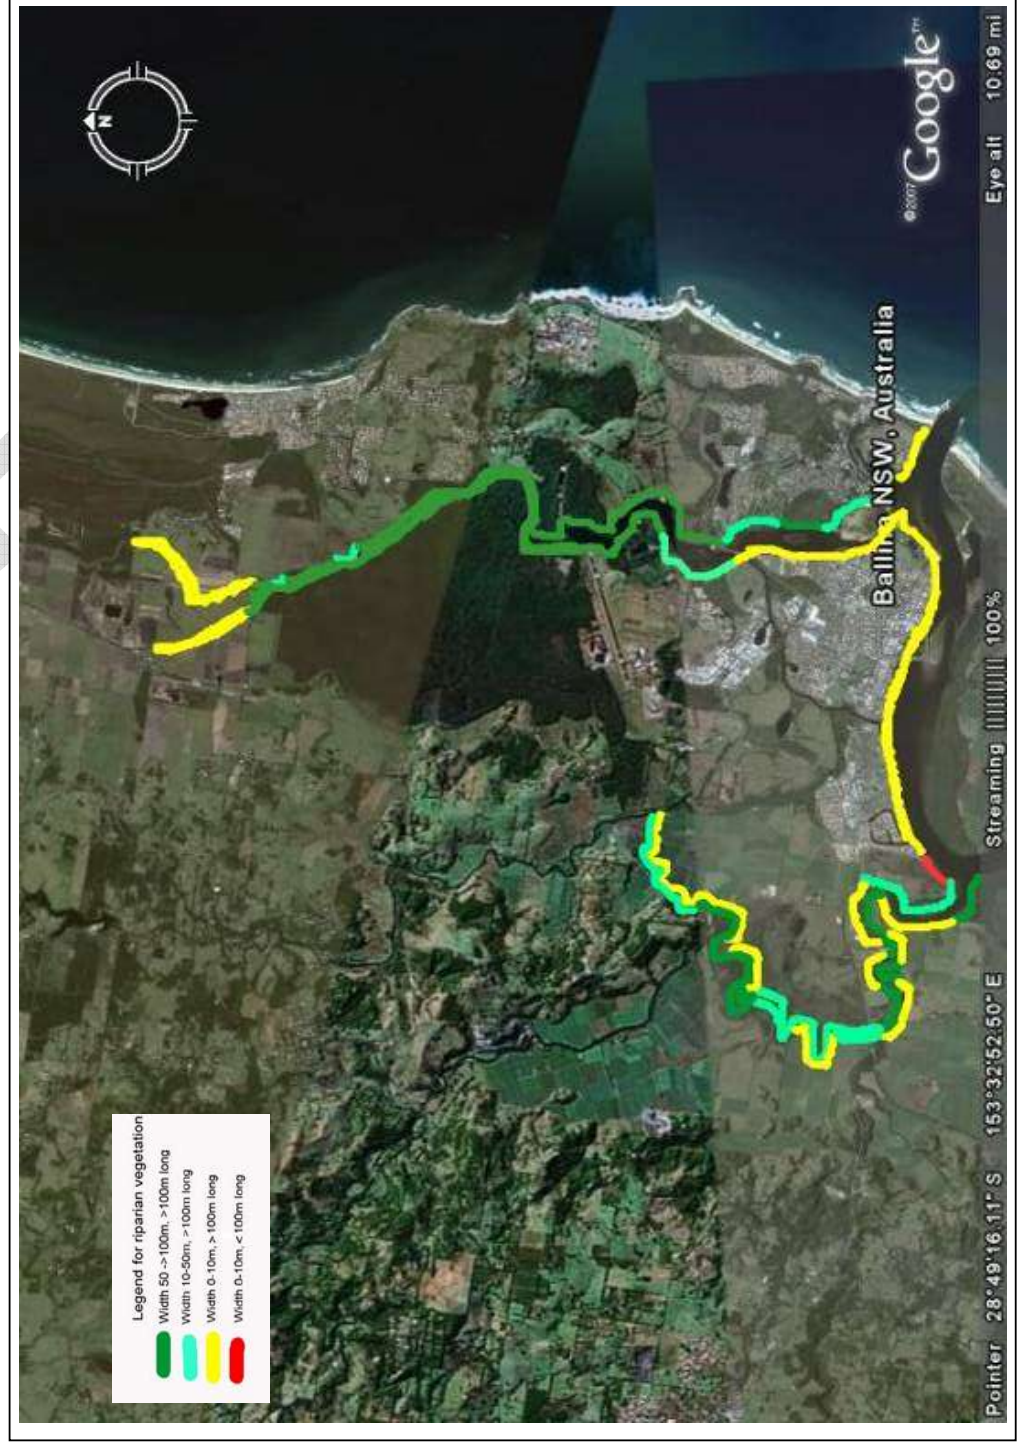
Using aerial photography and on-ground assessment, the following maps have been compiled to depict riparian vegetation width, with green being the widest (50-100m) and blue next widest (10-50m). Yellow areas show width less than 10m over a distance greater than 100m and red areas are less than 10m wide and less than 100m long.

Desktop
riparian
assessment
of the
North Creek
and
Emigrant
Creek area.

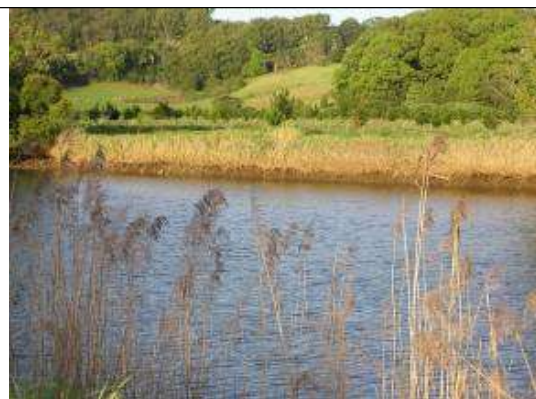
Macadamia plantation on the floodplain near Teven in background. Note bank erosion Maguires Creek.

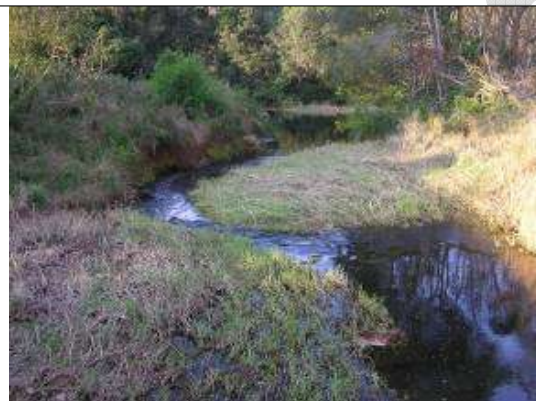
Confluence of Maguires Creek and Houghlahans Creek near Teven Golf Course. Note erosion scarp.

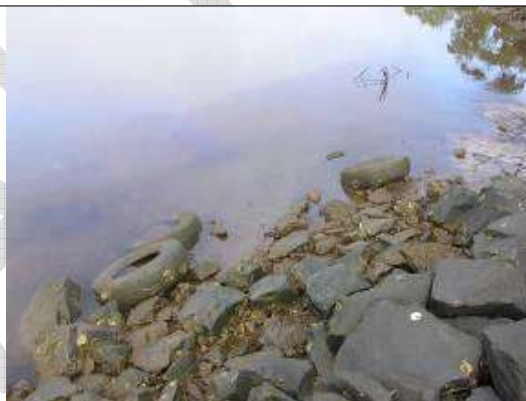
Tyres dumped near Pimlico Island. Perhaps crude attempts at bank stabilisation.

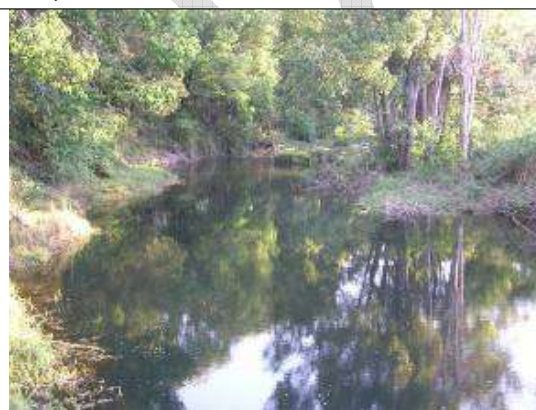
Bank slumping and weed infestation at Teven Bridge, Maguires Creek.

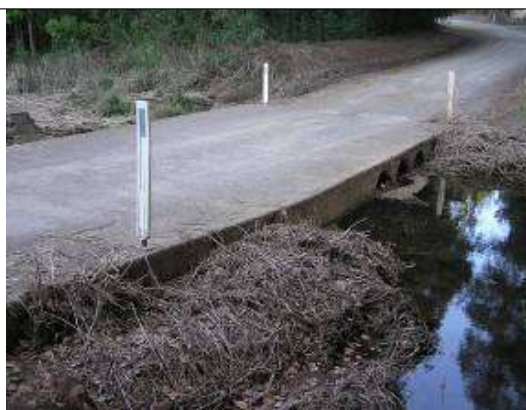
Dirt road and exposed bank at the causeway over Pearces Creek, Pearces Creek Hall Road.

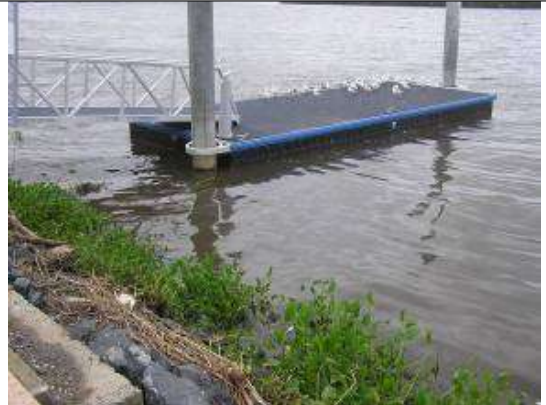
Water Hyacinth deposition and dead fish near Byrnes Point ferry after the fish kill in February 2008.

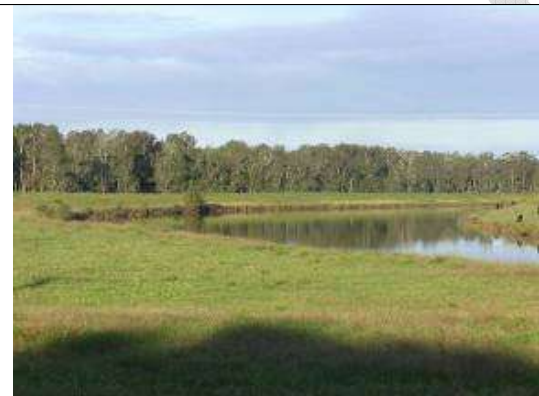
Bank erosion on Tuckombil Canal (Site E19).

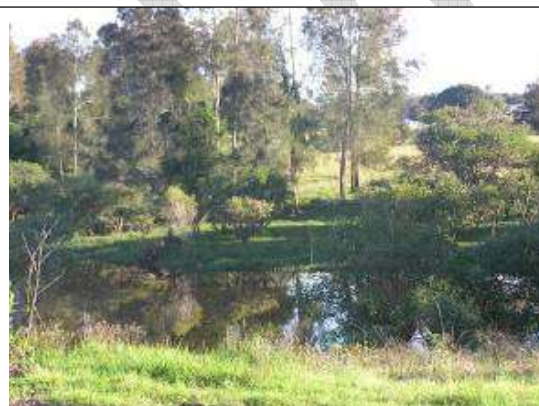
Coral Tree invasion on the lower river bank at Tuckombil Canal (Site E19)

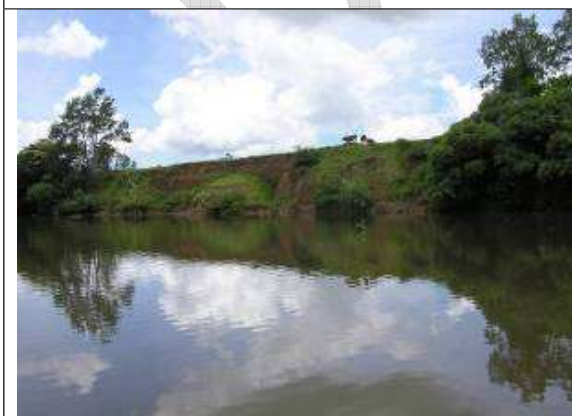
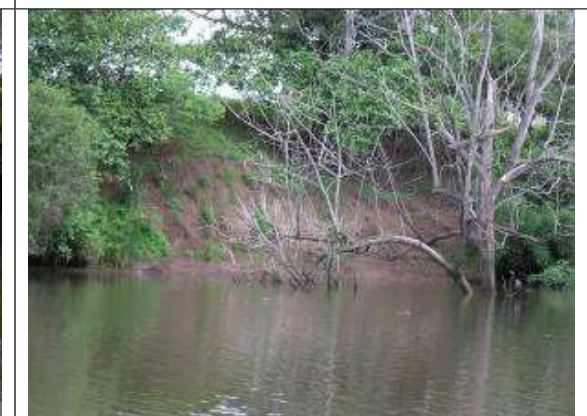
<p>Severe bank slumping, Wilsons River.</p>	<p>Slumping causing tree fell into the River, Wilsons River.</p>

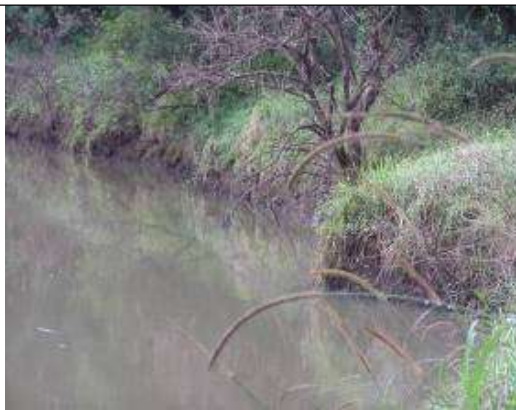
Undercutting of banks	Upstream of the site
