Dungarubba Canal Active Floodgate Management Plan

2021-2024

Management Plan operational summary

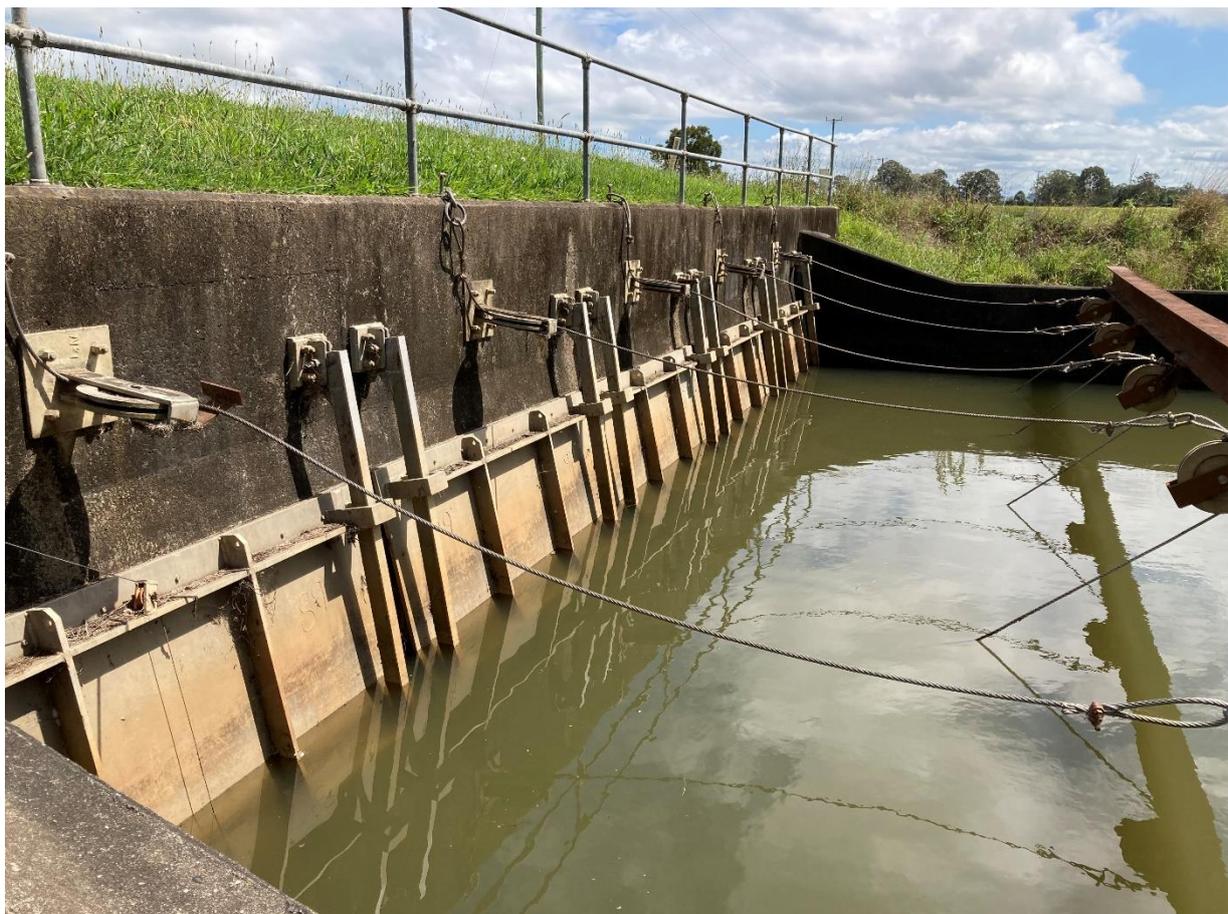
2: Dungarubba Canal floodgates and headwork structure.

The canal is floodgated at its junction with the Richmond River. A large concrete headwork structure has been constructed through the natural river levee and five floodgates installed on the downstream side. The central floodgate has been modified with a sluice window to allow tidal exchange. It is that modification to which this Plan applies. The term 'floodgate' within this Plan refers to the sluice window that is opened and closed to allow tidal exchange between the drain and the Richmond River.

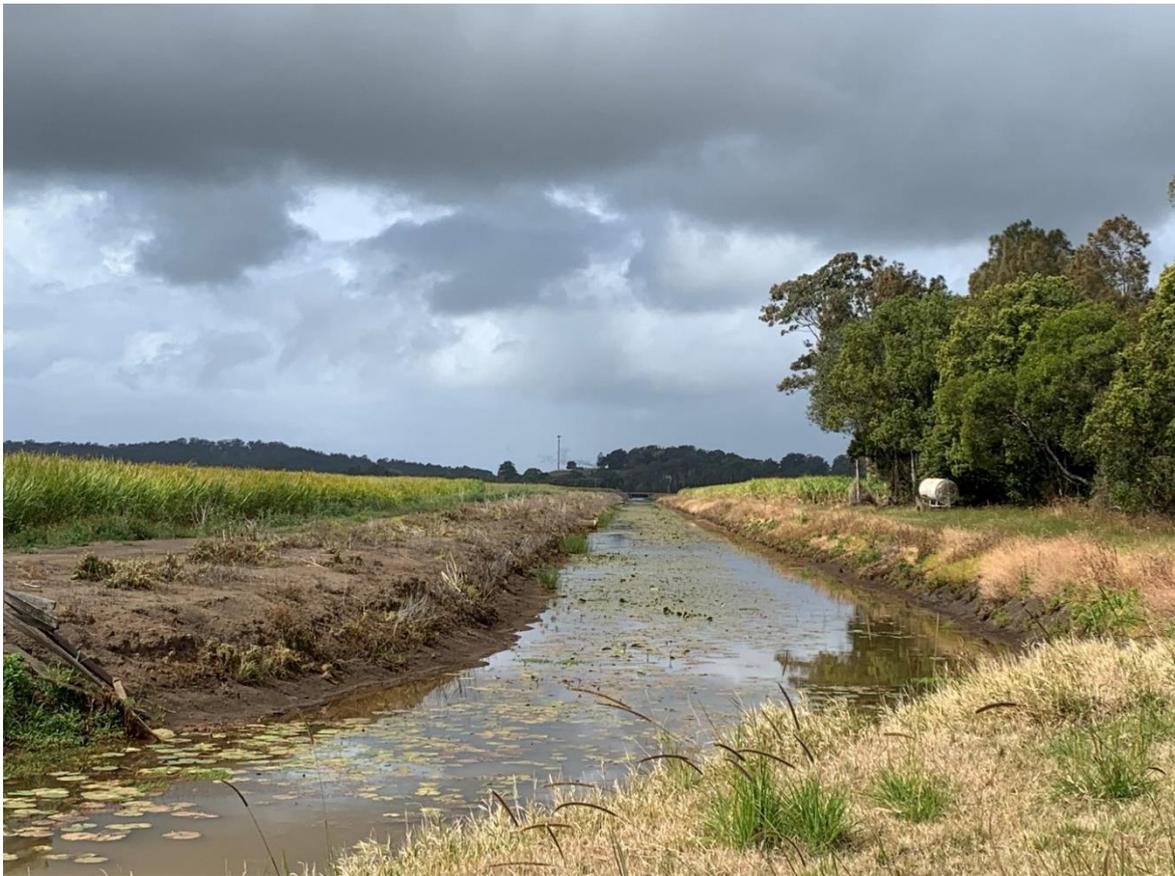
3: Dungarubba Canal looking downstream towards the floodgate headworks.

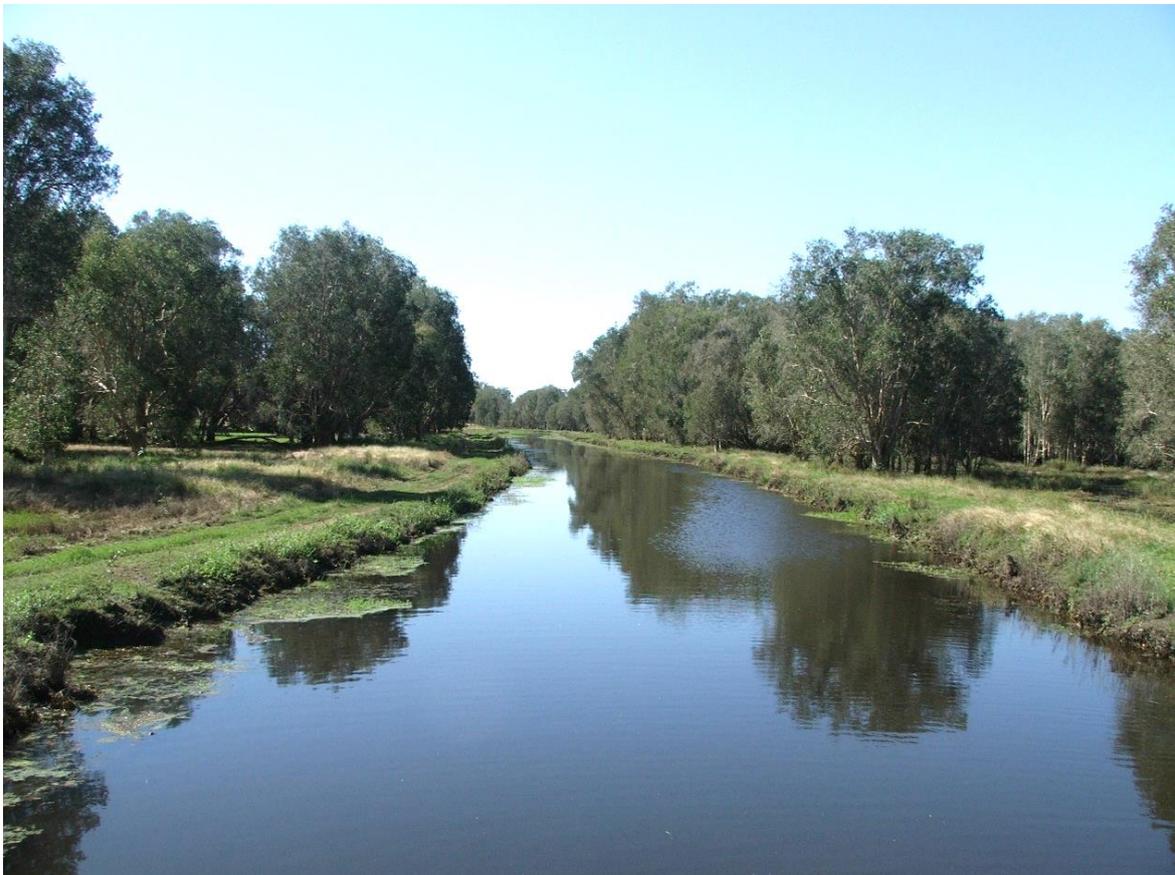
4: Dungarubba Canal as it travels through the lowest lying section, approximately 3 kilometres upstream from the floodgates, note the low bank heights in relation to the drain water level.

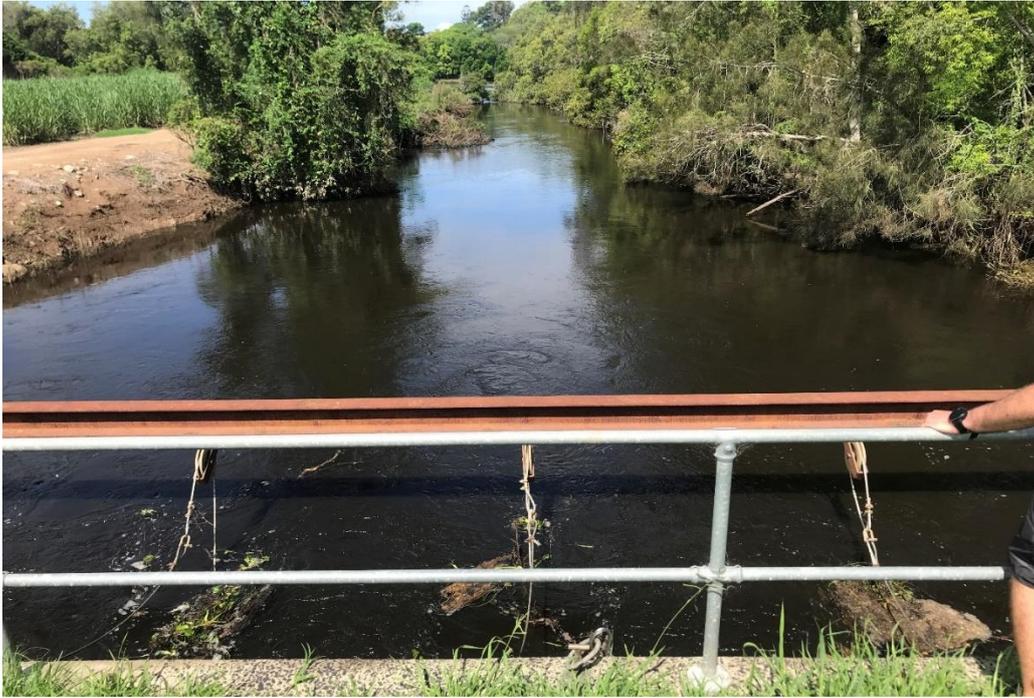
5: Deoxygenated water or blackwater discharging from the Dungarubba floodgates after flooding in February 2020.

After major summer floods, Dungarubba Canal can discharge large volumes of deoxygenated water or blackwater into the Richmond River estuary. Blackwater is generated when low-lying areas are inundated and the flooded vegetation rots. The canal drains a very large low-lying basin, which is a meter above average sea level (1m AHD) and below. This area can be inundated for lengthy periods of time. After flooding in February 2020, blackwater was recorded discharging from the canal with dissolved oxygen levels ranging from 0.1 to 1.9 mg/L, which are lethal for aquatic life.

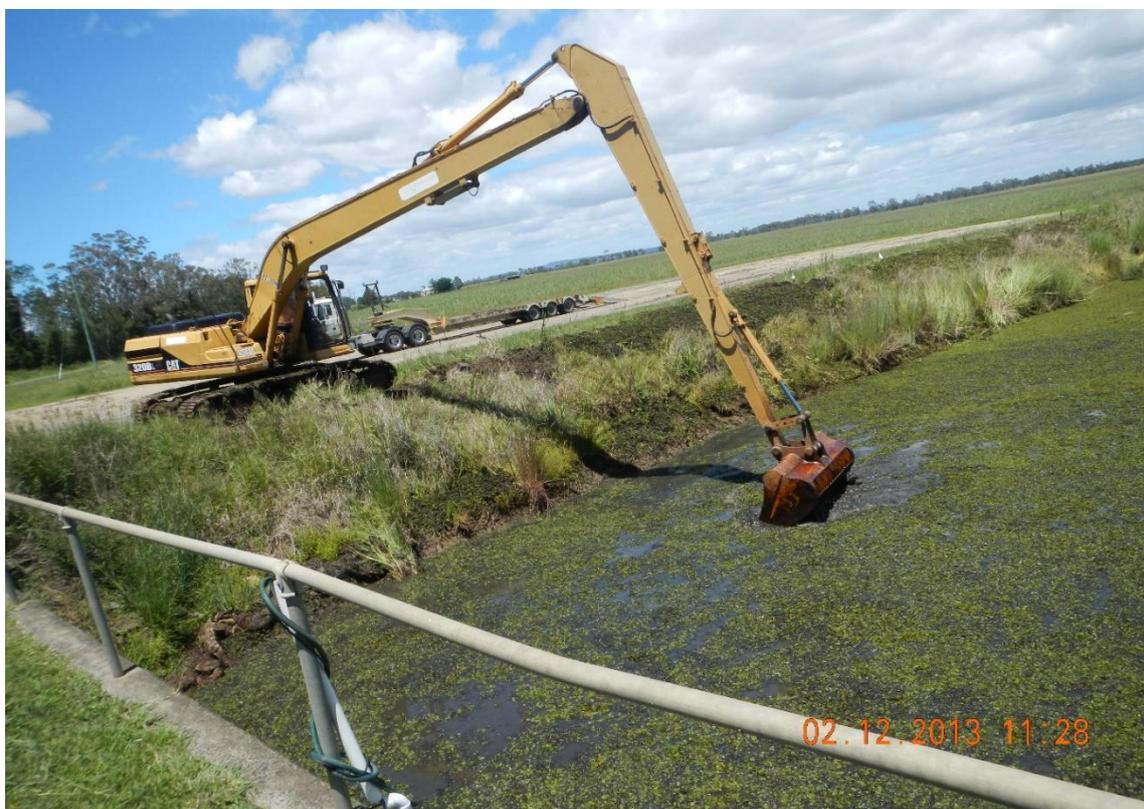
6: Council removing a build-up of vegetation from behind the floodgates.

Associated with the canal having low flows and limited tidal exchange, allowing nutrients and organic matter to accumulate, is excessive vegetation growth. These conditions allow aquatic vegetation to proliferate, including a species locally called ribbon weed or eel grass. Excessive aquatic vegetation causes problems when it is pushed downstream in large quantities where it can block the floodgate cells and prop open floodgates, preventing them from closing properly. Pictured below is Council removing a build-up of vegetation from behind the floodgates with an excavator in 2013. Council has also previously mechanically cleaned sections of the canal to remove excessive vegetation, which can block and prohibit flow. Again, active floodgate management and increasing tidal exchange can reduce these risks by limiting the amount of vegetation that grows in the canal in the lower sections.

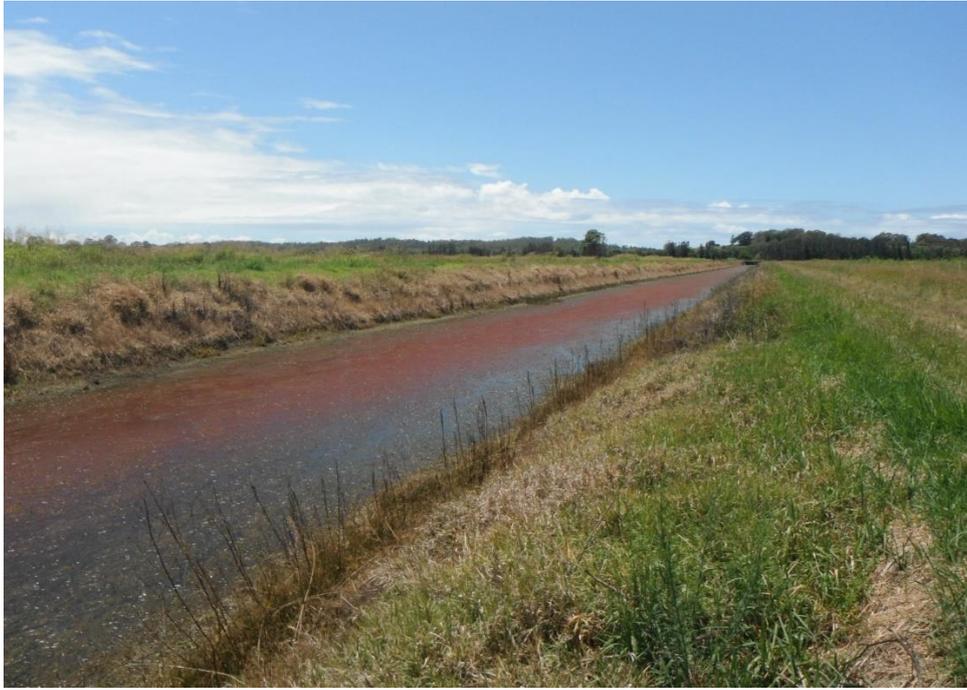
- This is the first 2.5km of the canal where the invert (height of the bottom of the drain) is at the same level or below that of the bottom of the floodgates.
- There is no fall in the canal through this section (ie. it is flat).
- The banks are relatively high, ranging between 1.1m-2m above average sea level (AHD). The surrounding land is also high.
- This area is cropped with sugar cane.

7: Showing the characteristics of the section closest to the floodgates.

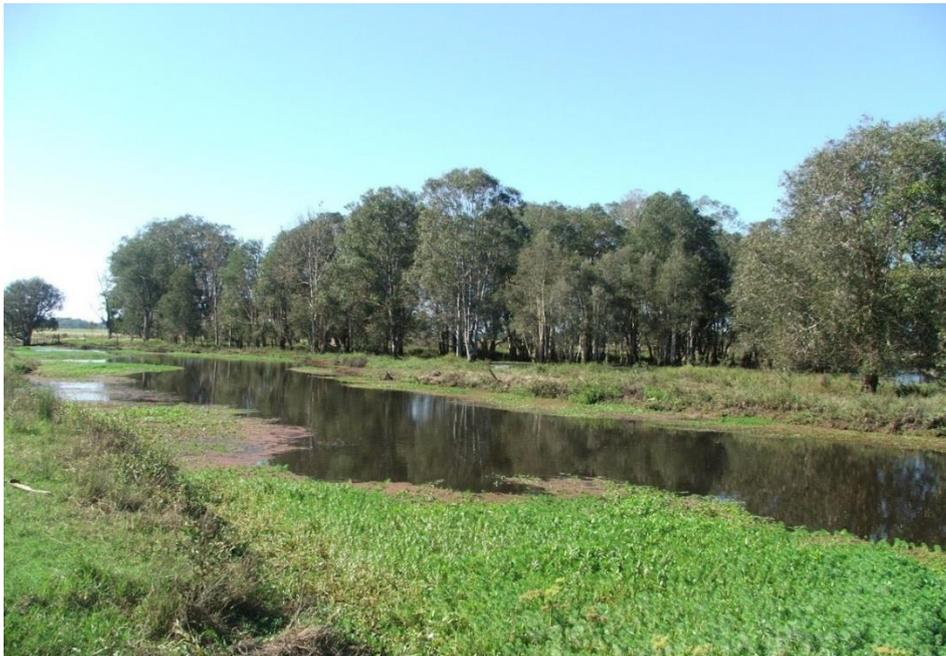
- The middle 2.5km section is characterised by very low banks and the surrounding land is also very low.
- The surrounding land adjacent to the canal ranges from 0.08m – 0.96m above average sea level (AHD) with large areas between 0.10m-0.40m above average sea level.
- The banks of the canal through this section range from 0.40m-0.88m above average sea level.
- There is a rise (ie. a hump) in the canal's floor 3.5km up the drain from the floodgate in the lowest lying section. The rise is 795m long and at its highest sits 0.25m higher than the invert of the floodgate. This rise is thought to be an accumulation of silt, where the drain flow slows down and suspended sediment in the water is allowed to drop out to the invert of drain.
- Upstream of this rise, the invert of the drain is lower than the floodgate.

8: Showing the characteristics of the low-lying middle section of the canal.

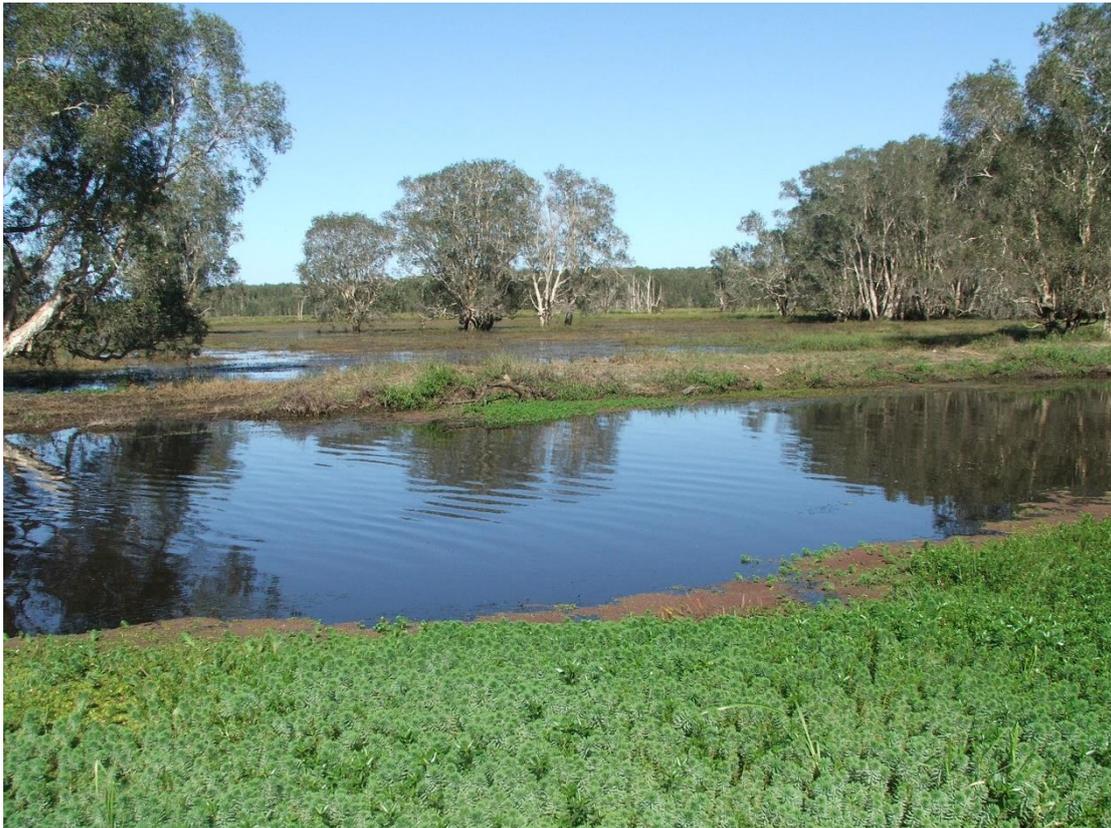
9: Drain overtopping that has previously occurred in the lowest lying section adjacent to the canal from uncontrolled tidal exchange in 2009.

The survey confirmed there are challenges in keeping the sluice window open for continuous tidal flushing. Trials that followed the survey were conducted with landowners in the lowest lying areas and showed that opening the sluice window, even conservatively, can significantly increase drain water levels in the middle section. That increase in drain water levels, together with unfavourable tides or heavy rain, can result in low-lying land adjacent to the drain being inundated.

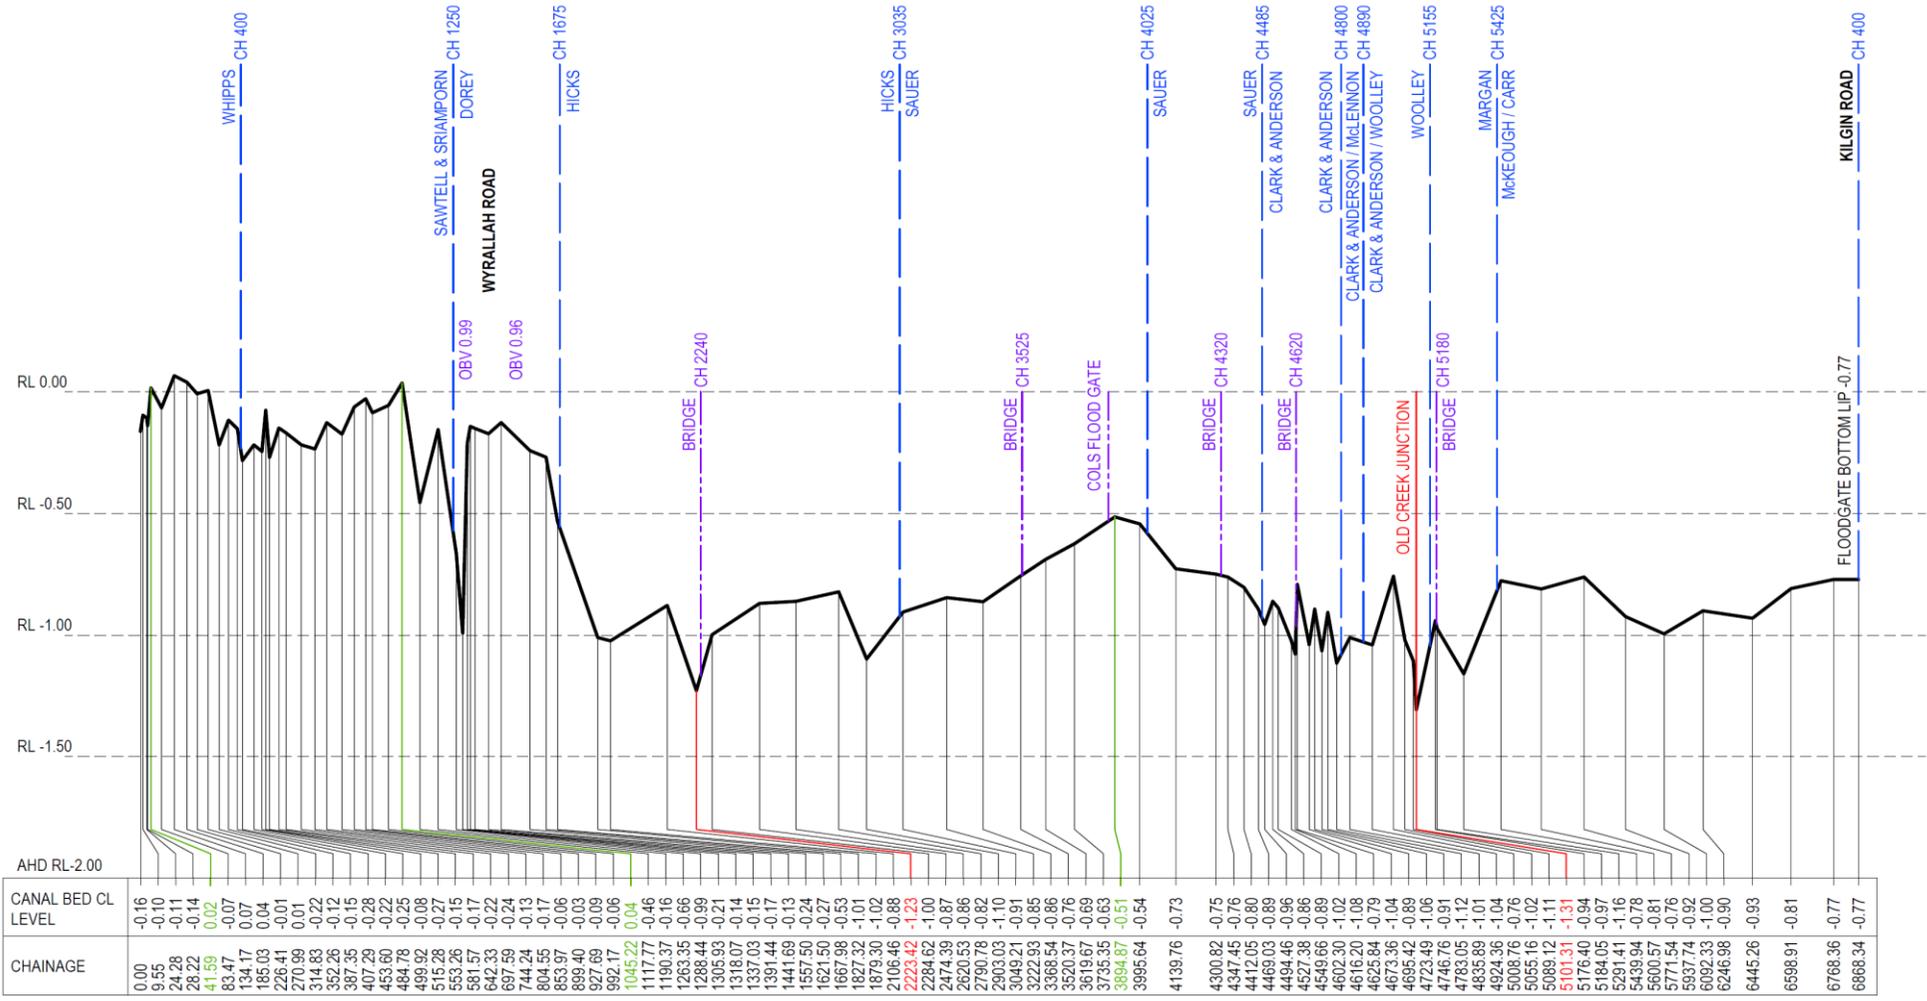
DUNGARUBBA CANAL LONGITUDINAL SECTION - CL

SCALE 1:20000 HORIZONTAL.
SCALE 1:20 VERTICAL.

The characteristics of the three sections gives the Dungarubba Canal a bathtub effect, with higher banks and land elevation above and below the very low-lying middle section.

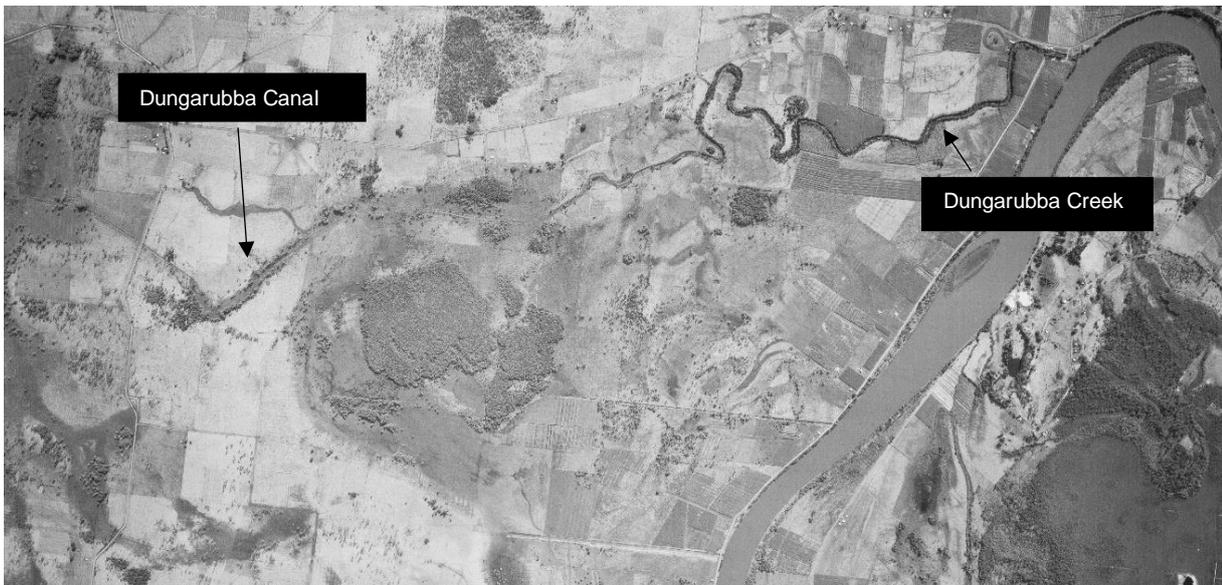
11: Historical aerial photograph of Dungarubba Creek and canal in 1964.

Historic aerial photography confirms Dungarubba Canal was eventually connected directly to the Richmond River between 1964 and 1966.

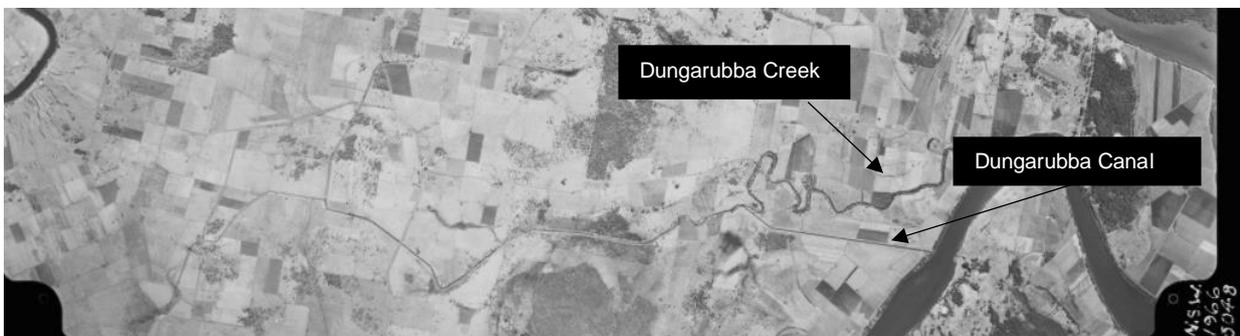
12: Historical aerial photograph from 1966 of Dungarubba Creek and canal after the canal was connected independently to the Richmond River.

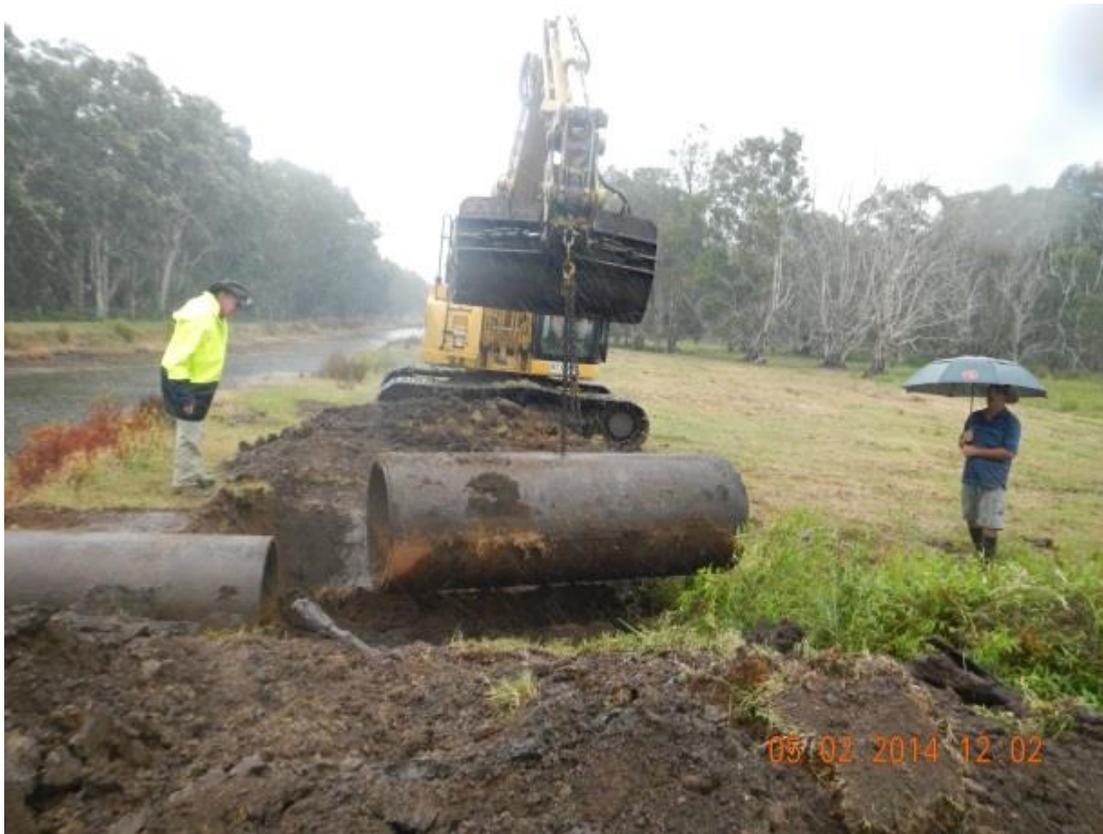
13: Secondary pipes and floodgates being installed in 2014 to restrict tidal water to the main canal.

Repeated attempts have been made to retrofit the drainage system with secondary floodgates and pipes to restrict tidal water to the main canal. This has included seven secondary floodgates on mostly private secondary drains in the lowest lying land over the past ten years. These have not been able to control the tidal water to the satisfaction of the landowners.

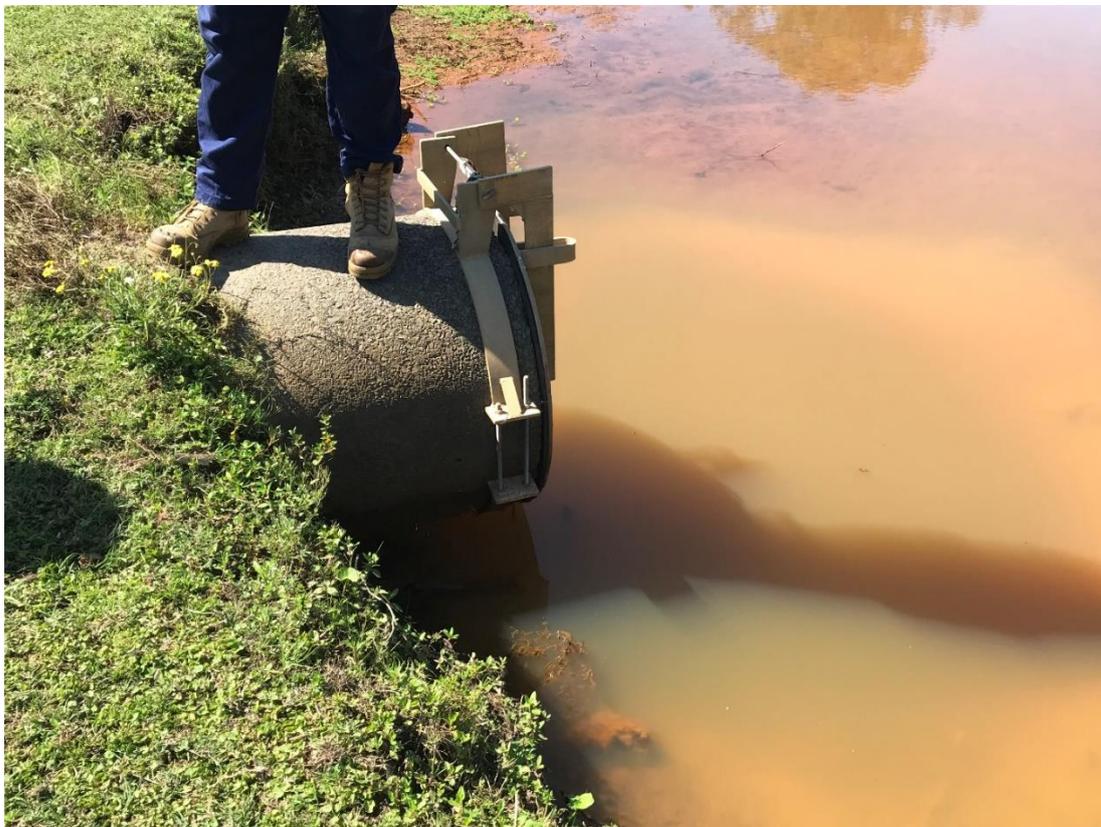
14: An example of the secondary pipes and floodgates installed along Dungarubba Canal, note the abundant flocculated iron in the drain water from acid sulfate soils.
