What is Ecohealth?

The Richmond catchment

Ecohealth monitoring was undertaken at 48 sites in the Richmond catchment between December 2013 and November 2014. There were 24 freshwater sites (represented by blue backgrounds on the site grades at right) and 24 estuarine sites (represented by green backgrounds). The results reflect the average health of the system over the 12-month sampling period. It provides a baseline measure of the aquatic ecosystem health of these river systems to which future monitoring can be compared. Site grades are organised longitudinally from left to right.

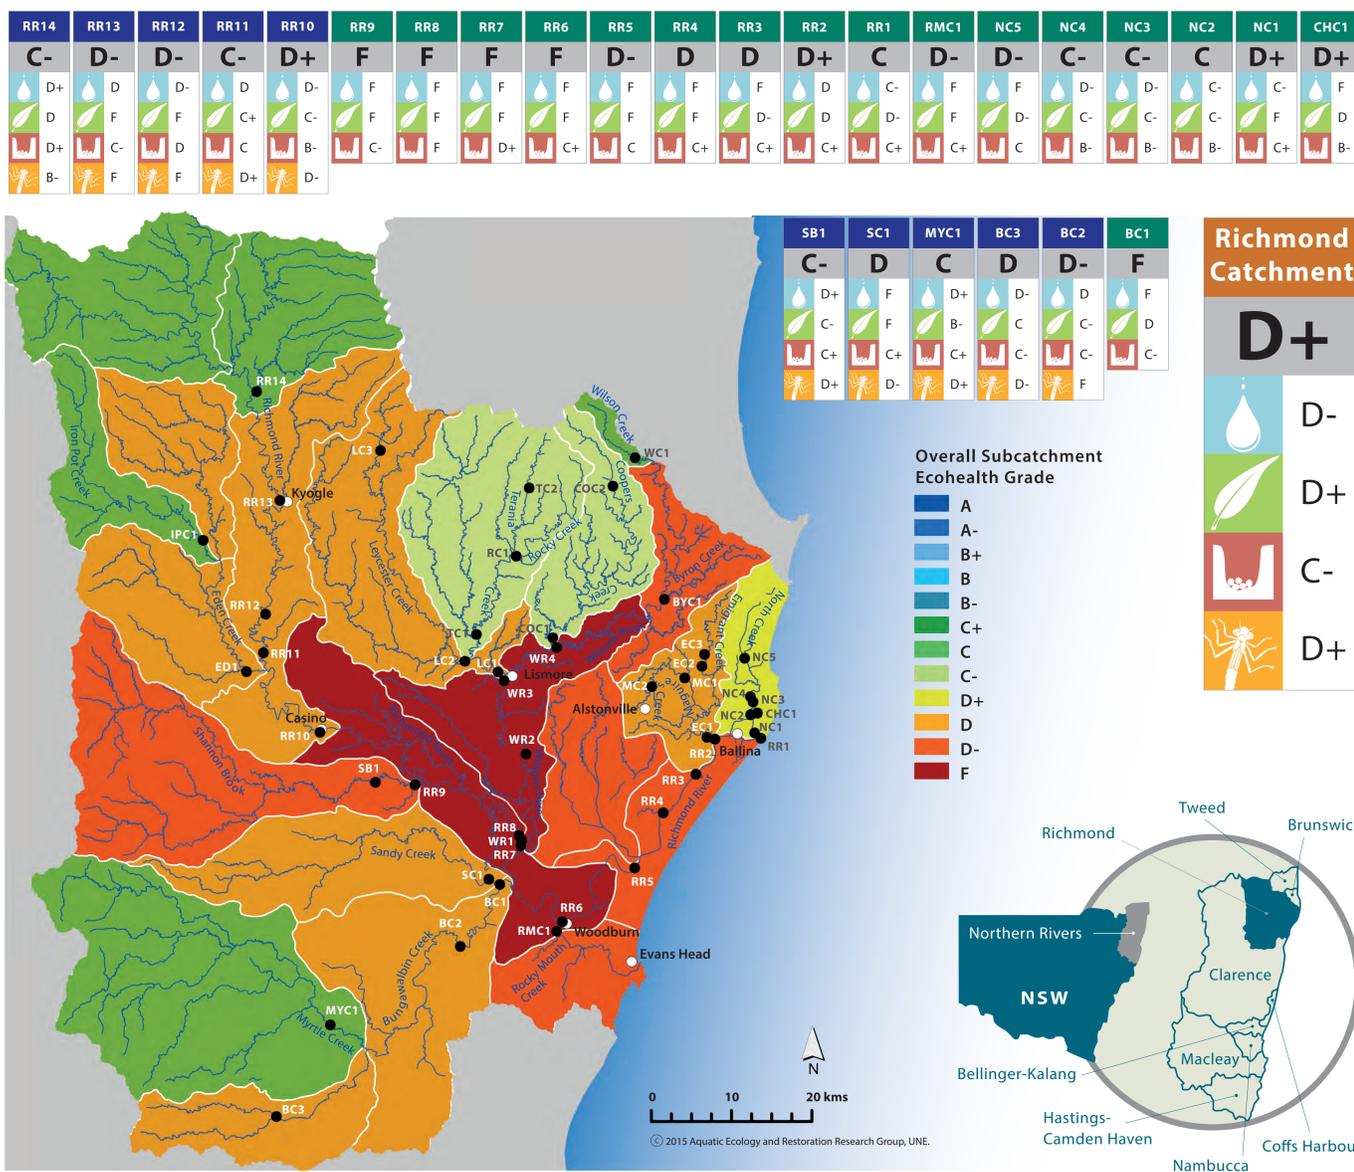
A total of 48 sites in 17 waterways in the Richmond catchment were used to calculate an overall condition of D+ for the catchment (see below). This score is consistent throughout the Richmond catchment with 12 of the 17 waterways recording a score of D or lower. The upper freshwater reaches of the Richmond catchment had better water quality, aquatic macroinvertebrates and geomorphic condition than the lower freshwater reaches, but no better riparian condition. The upper estuary (upstream of Woodburn) was consistently in the poorest condition, with very high nutrient concentrations, turbidity and algal biomass. Scores were consistent among indicators within each system, highlighting that water quality and physical habitat are driving the condition of streams.

WC1	BYC1	WR4	WR3	WR2	WR1	COC2	COC1	TC2	RC1	TC1	LC3	LC2	LC1	MC2	MC1	EC3	EC2	EC1	IPC1	ED1
C+	D-	D	F	F	F	C+	D+	B	B-	F	C	F	D-	C	D+	C+	D-	D	C-	D-
C-	D-	F	F	F	F	C-	D	C	C	D	D	D	F	C-	D	C+	F	D-	D+	D-
B-	F	C	F	F	F	B	D+	B+	C+	F	D-	D-	D-	F	F	D+	F	F	C	D+
B-	D+	D	C+	C-	D-	B-	D+	B-	B-	D+	C	D+	C+	B-	C	C+	C+	C	D	D-
C	D-	D	C+	C-	D-	C	D+	B+	B	F	B-	F	C	C	C	C	C	C	C	F
