Saltwater Creek Scoping Plan for Active Floodgate Management

2021-2024

1. Site background and characteristics

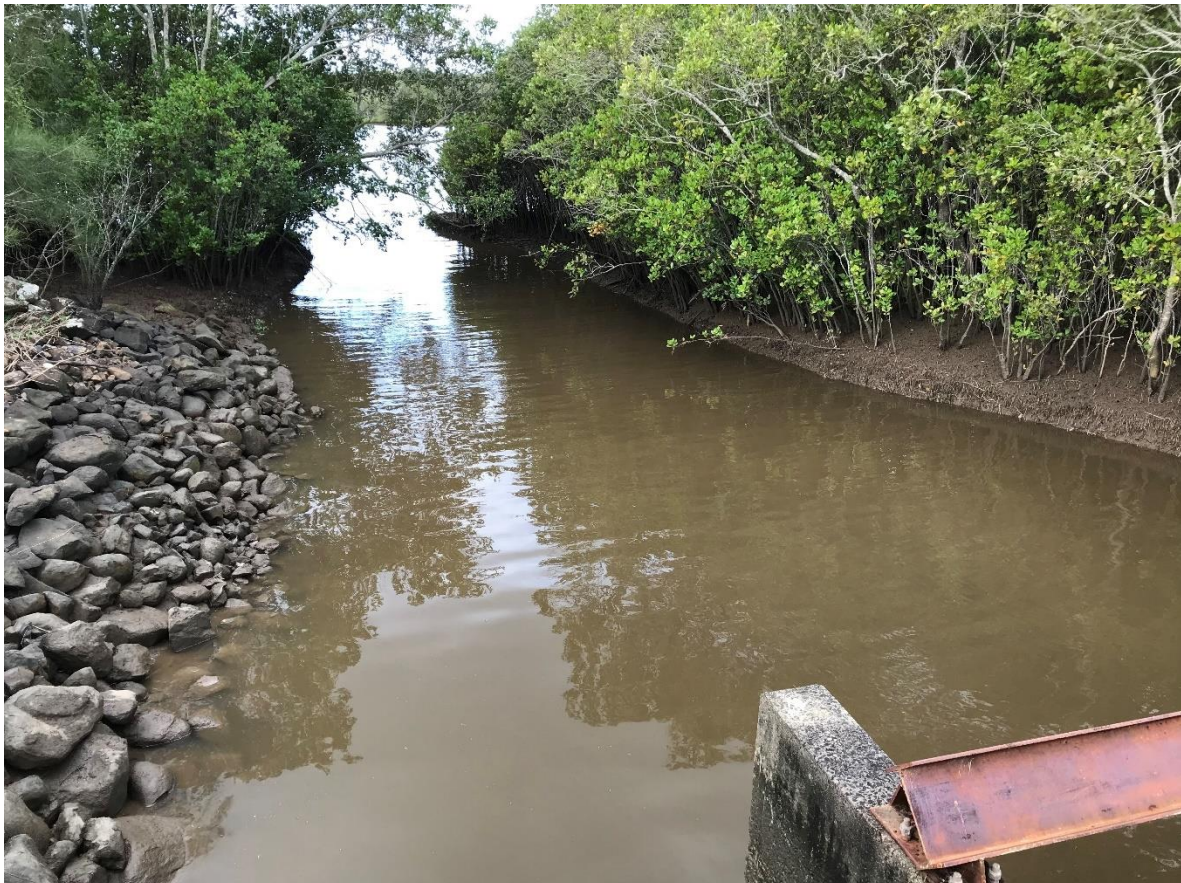
2: Saltwater Creek floodgate outlet.

- Three square 1,500mm floodgates, one with a sluice window operated with a winch.

Asset No.	Description	Number
4280-290	Outlet	1
4280-030	Aluminium floodgate (1500mm square) one modified for tidal exchange with a sluice window (50cm aperture).	3
4280-610	Handrail	2
4280-260	Saltwater Creek (canal)	1
6900-410	Saltwater Creek levee	1

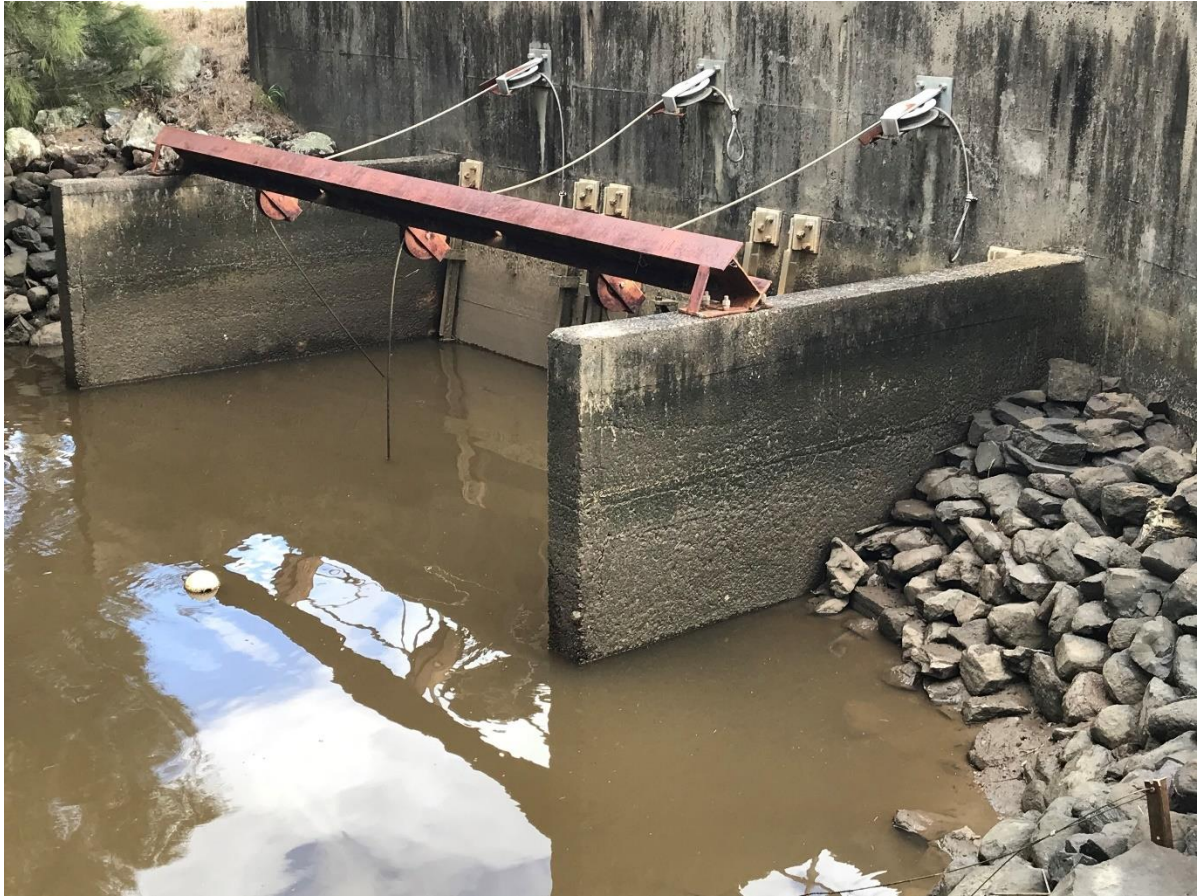
3: Saltwater Creek floodgates.

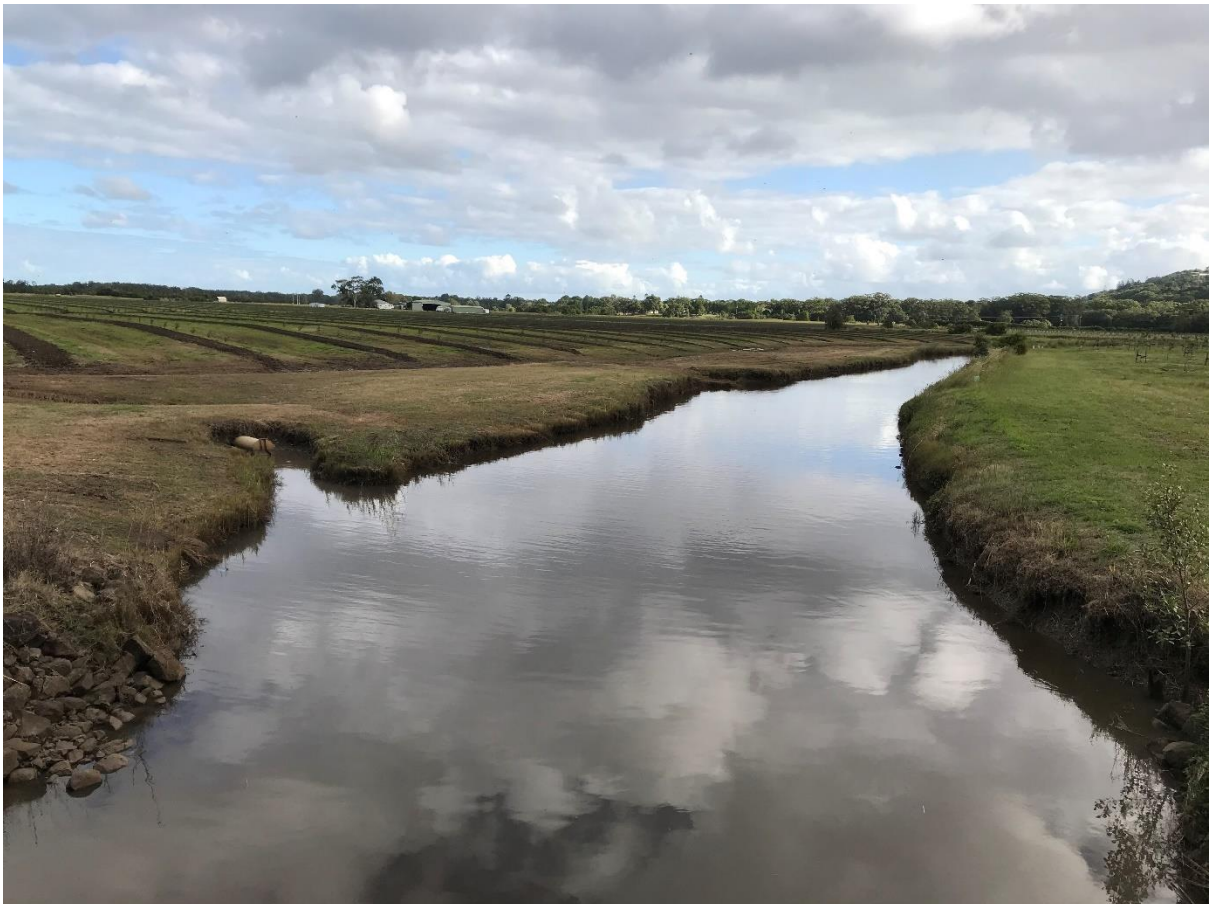
*4: Saltwater Creek looking immediately upstream of the floodgates.
Note the low-lying area immediately to the left of the image.*

Undertaking active floodgate management at Saltwater Creek has been difficult. There is very little height difference between normal water level in the creek and the surrounding land to the south. Advice from Rous County Council staff is that there is a high risk if the sluice is open, even 50-100mm, because of the elevation of the land, along with the large tidal range and high salinity in this part of the estuary. Keeping the sluice open, even at a conservative aperture, would result in land upstream being regularly inundated with very saline, tidal water. This advice is supported by the long-term landowner and his previous experience.

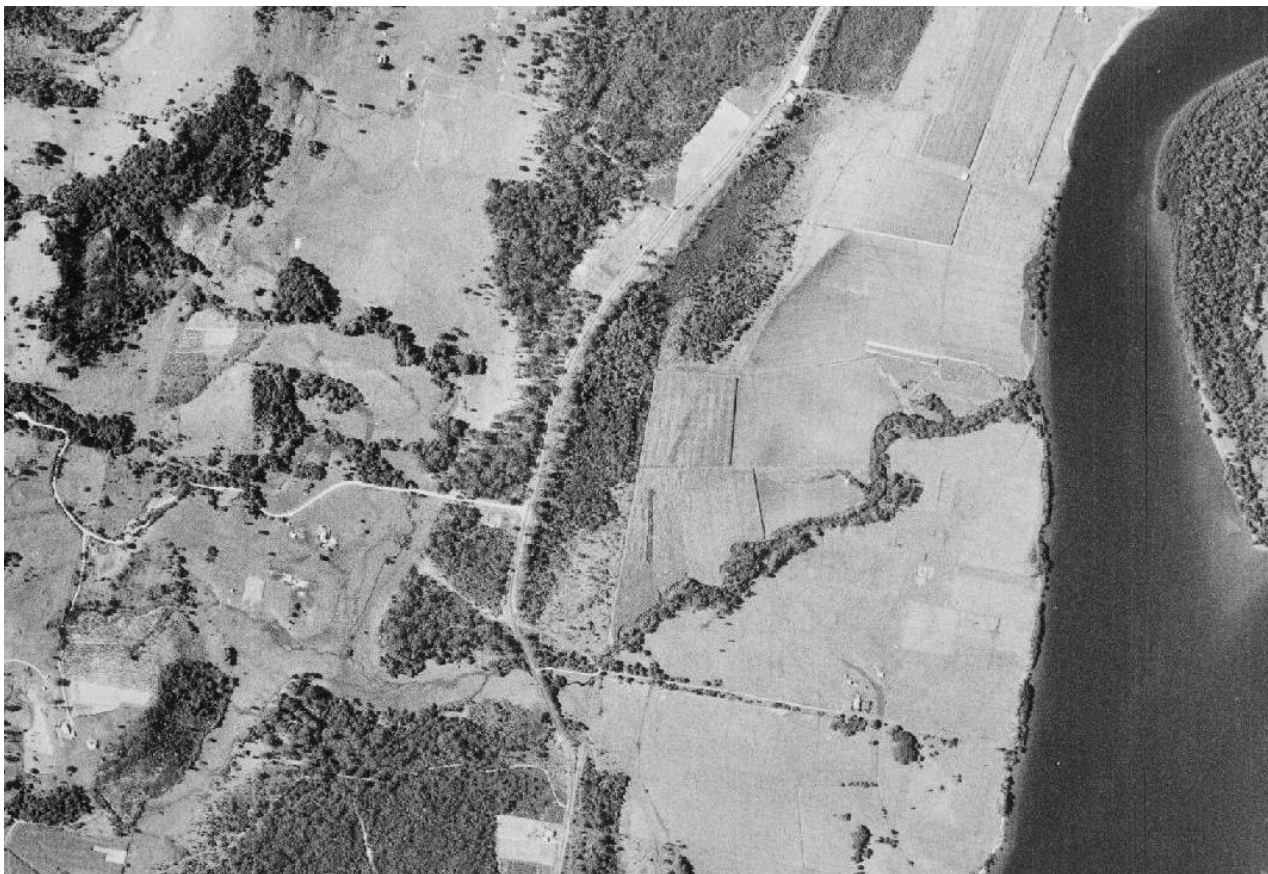
*5: Aerial photograph of Saltwater Creek taken in 1958.
Note riparian vegetation present along the lower reaches of the creek.*

Being a natural waterway, Saltwater Creek would have provided aquatic habitat prior the floodgates being installed and the riparian vegetation removed. Historic aerial photography shows that in 1958 the lower half of Saltwater Creek on the floodplain had continuous riparian vegetation (see Figure 5). Eight years later in 1966, all of the riparian vegetation had been removed and sugar cane cropping had expanded (see Figure 6). These changes, together with the floodgating of the creek, completely altered the nature and function of the system.

Sugar cane was historically grown in the Saltwater Creek area, with a reference made as far back as 1893 in local newspapers. However, this was likely to have been only on higher elevation land (see Figure 5), and expansion on the low-lying floodplain areas surrounding Saltwater Creek only occurred after the system was floodgated (See Figure 6).

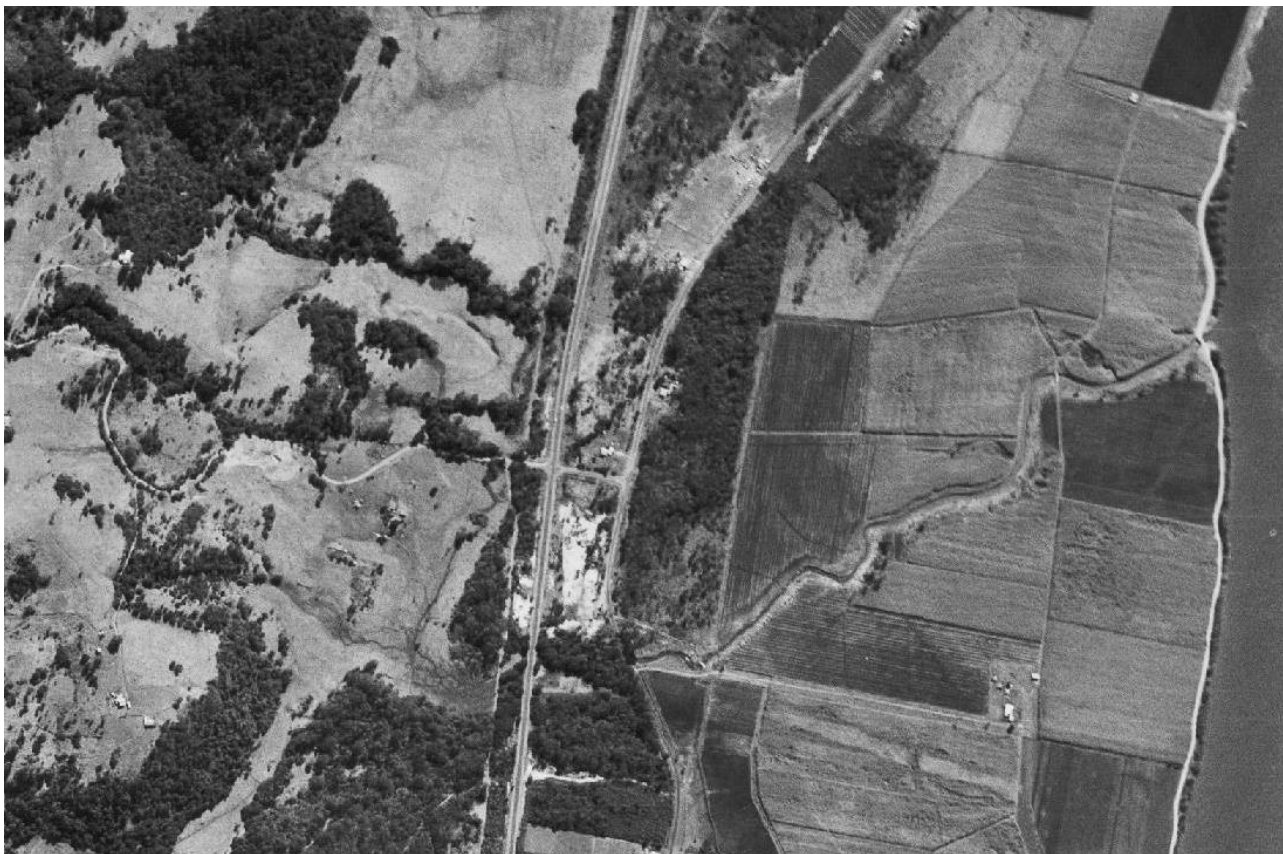
*6: Aerial photograph of Saltwater Creek taken in 1966. Note that in eight years since 1958,
all of the riparian vegetation has been removed from the lower reaches of the creek.*

There is no historical information on when and why the floodgates at Saltwater Creek were constructed. The existing main headworks and floodgates are likely to have been installed in between 1958 and 1966, coinciding with the removal of riparian vegetation and expansion of sugar cane.

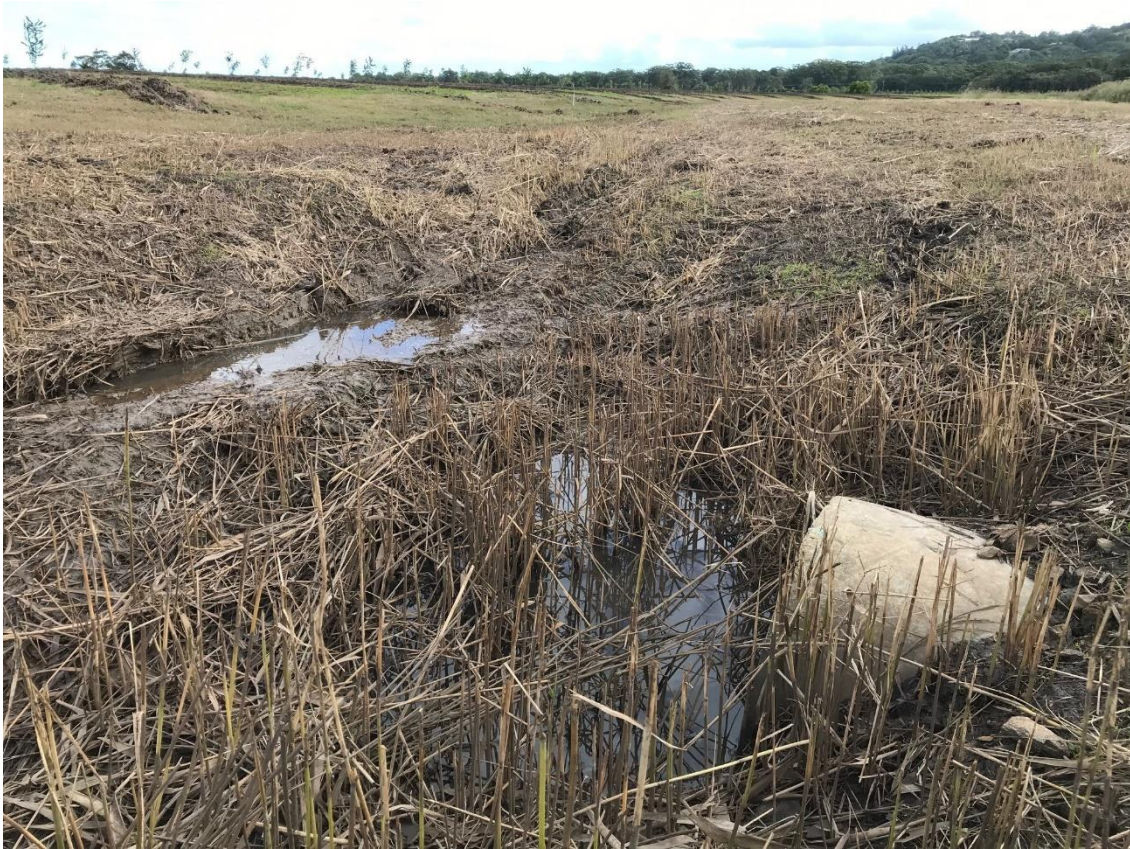
8: Photo of low-lying area alongside the southern side of Saltwater Creek, showing a previously installed pipe, and to the right of the image the small bund that was constructed. Note the pipe is not draining recent rainfall from this area.

During an initial trial of tidal exchange in November 2006, the drain banks overtopped and caused significant inundation of sugar cane crops with very saline, tidal water. To reduce the risk of this occurring again, Richmond River County Council installed a small bund alongside the southern side of the creek and included pipe crossings to drain water from behind the bund into the creek. Richmond River County Council provided the material to create the 500m bund, the seven concrete and green pipes and tidal flaps. In 2008, the works were completed, however the landowner raised concerns over whether the works would be sufficient to prevent tidal inundation.

Unfortunately, the retrofitting that occurred was not successful in reducing the risk of inundation and many of the pipes and floodgates are now in disrepair (Figure 8 and 9). Due to the risks involved, regular tidal exchange never occurred as planned in the Active Floodgate Management Plan.

- Retrofitting could include:
 - Replacing the broken pipes and floodgates, and/or
 - Constructing a higher bund or levee along the creek.
- The landowner on the southern side of the creek has indicated he may be interested in revegetating along the creek bank with native species.

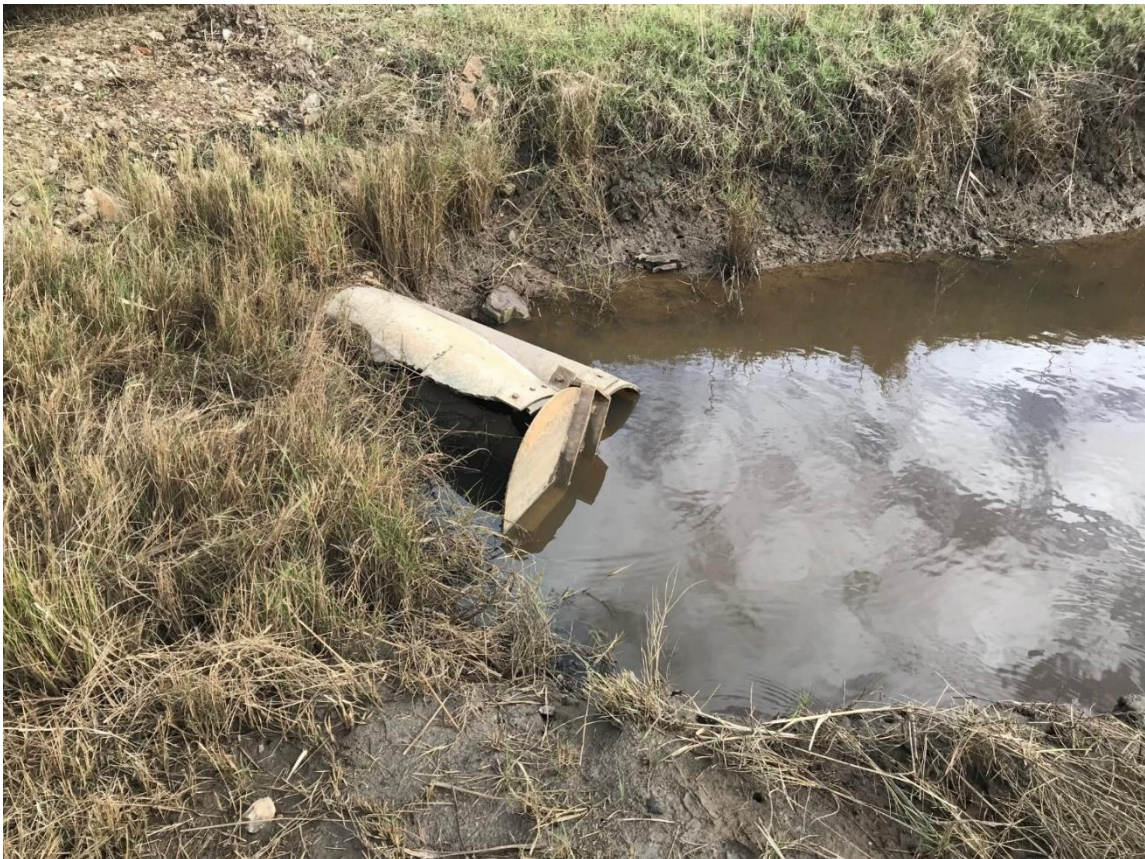
9: One of the previously installed pipes and floodgates currently in disrepair.
