North Woodburn-Kilgin Drain Active Floodgate Management Plan

2020-2023

Management Plan operational summary

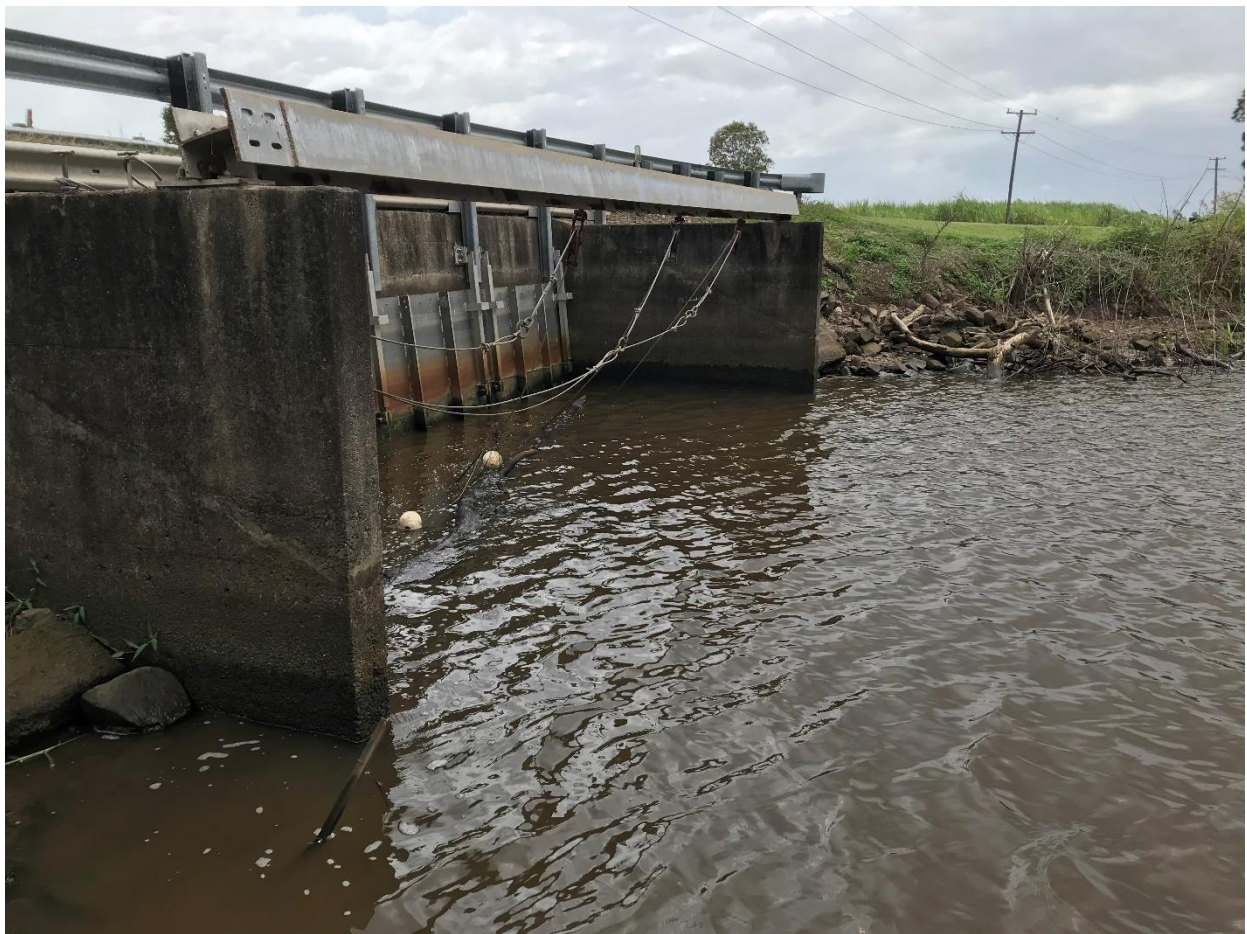
2: North Woodburn-Kilgin drain floodgates.

The drain has been floodgated at its junction with the Richmond River, with a large concrete headwall that Kilgin Road runs over. Five floodgates are installed on the downstream side, one of those has been modified with a sluice window to allow tidal exchange. It is that modification to which this Plan applies. The term 'floodgate' within this Plan refers to the sluice window that is opened and closed to allow tidal exchange between the drain and the Richmond River.

- Five square 2,400mm floodgates, one with a sluice window operated with a winch.

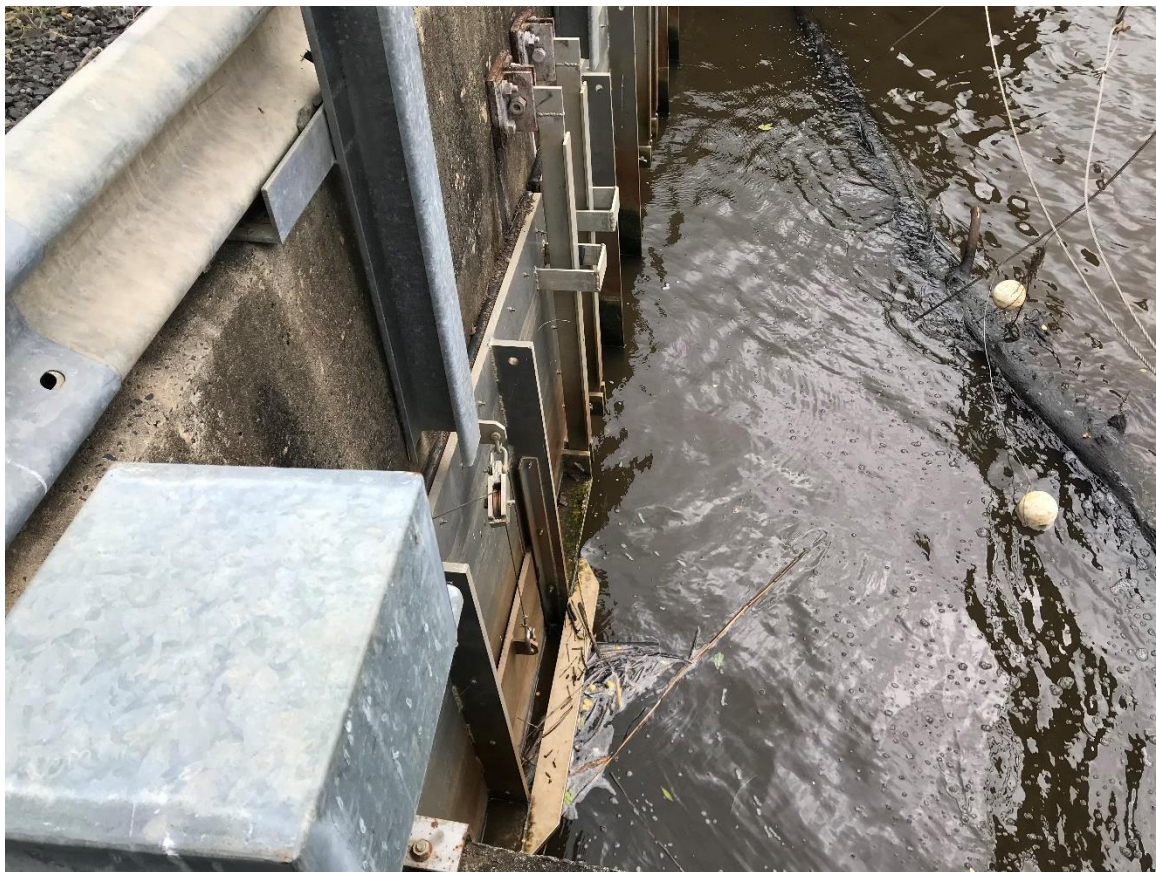
3: Sluice window installed on the floodgates at North Woodburn-Kilgin drain.

A floodgate on the North Woodburn-Kilgin drain is fitted with a sluice window, which can be winched open. The sluice window requires careful management to reduce the risk of negative impacts on properties upstream. The land surrounding the drainage system is very low and there is little freeboard between normal drain water level and the surrounding land. This increases the risk of prolonged inundation after rain events and overtopping and inundation of land from tidal water. The operational strategy for this sluice window has been developed and refined by the landowner volunteer over many years and the review of this management plan is an opportunity to document it in detail.

- The sluice window is fitted with a winch and large forces can be involved in winch systems.
- The sluice window should only be opened on a low or falling tide. This will reduce the risk of the wire rope breaking and the floodgate bowing.
- The sluice window is opened and closed by nominated landowner volunteer or Council operator, who should consult and follow the approved Safe Work Procedure and Floodgate Fact Sheet relevant for the activity and undertake their own risk assessment before operating the floodgate.
- Operating the sluice window during and after heavy rain or flooding can require working in wet and slippery conditions. Safe access to the site should be assessed after events.
- The sluice window is only to be operated during daylight hours.

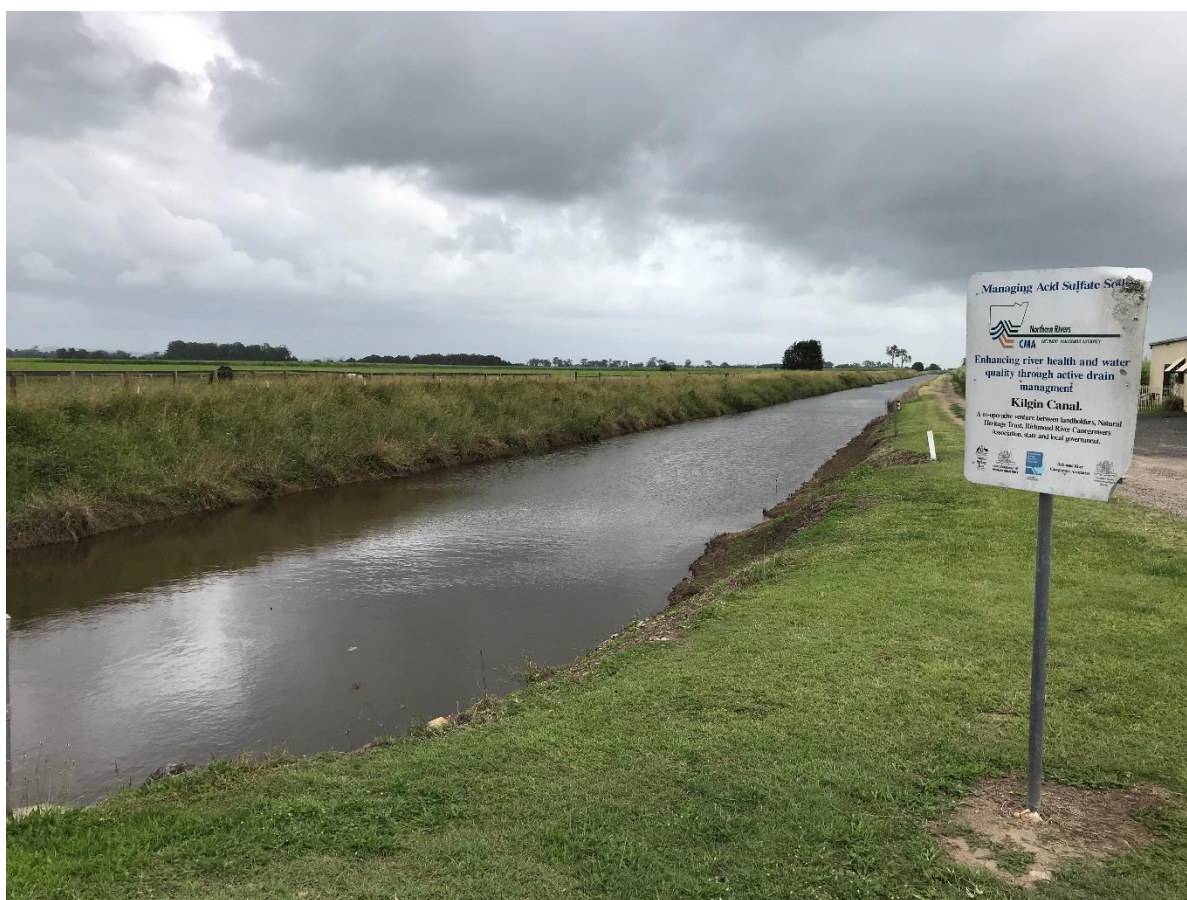
4: North Woodburn-Kilgin drain looking upstream from floodgates
