# **Haughwood Canal Active Floodgate Management Plan**

**2019-2022**

## 2. Haughwood Canal

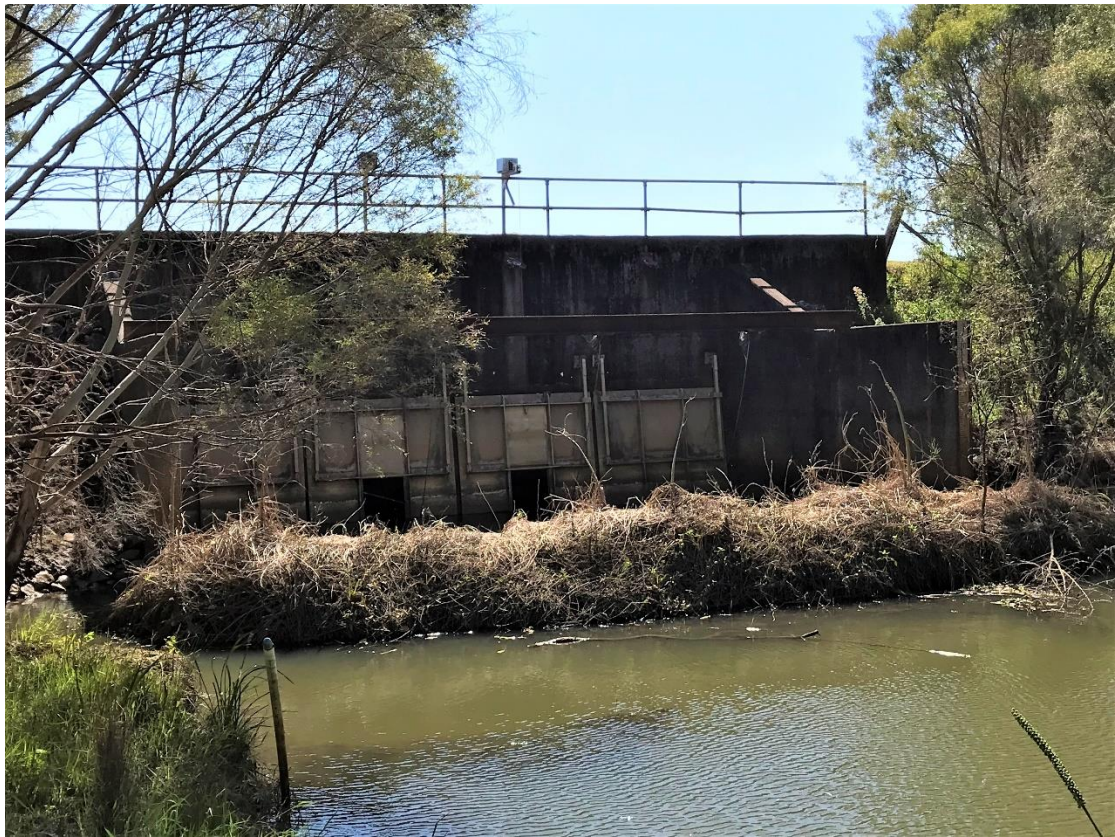
*2: Haughwood Canal floodgates with sluce windows open.*

Two of the floodgates on Haughwood Canal are fitted with sluice windows, which can be winched open. The sluice windows remain fully open all year, and are only lowered before flood events to protect upstream areas from riverine inundation. This is the optimal strategy for tidal exchange through the existing floodgate structure and no improvement is suggested at this time for its future management. This degree of tidal exchange is noted to improve water quality while having minimal impact on surrounding land use.

In 2006, when the existing steel floodgates were upgraded to aluminium, two sluice windows were installed in the new floodgates.

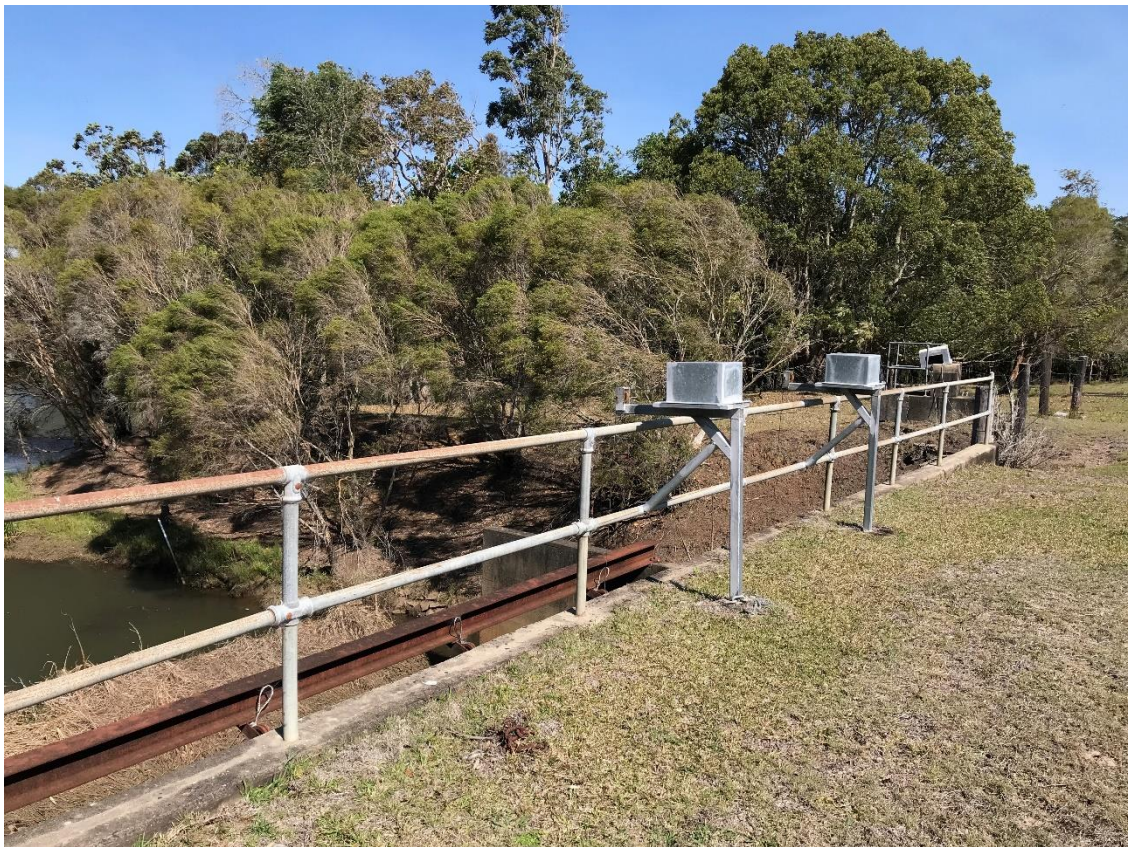
*3: Winches on Haughwood Canal headwall used to open sluce windows below.*

The floodgates already had a lifting winch installed, which landowners had used for many years to open the system for tidal flushing. The lifting gear was upgraded in 2003 to meet current work health and safety standards and allow landowners to operate the system.

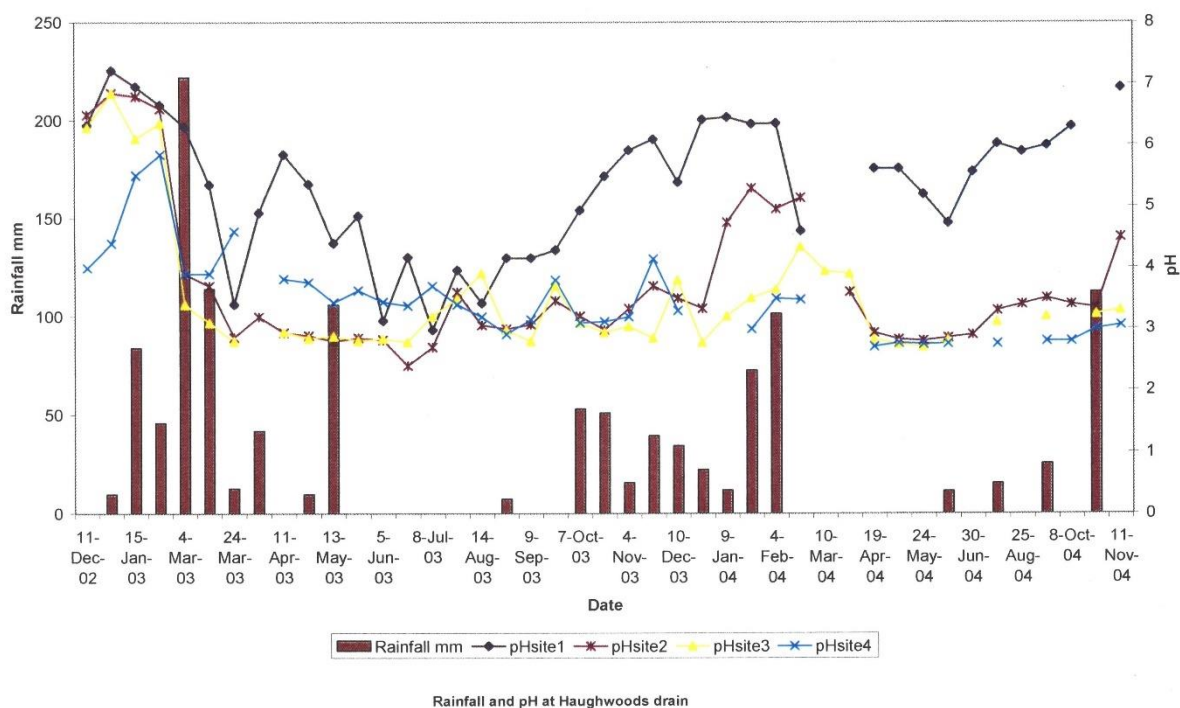
*4: Water quality within Haughwood Canal during 2003 and 2004. Site 1 is closest to the floodgates and Site 3 and 4 are located within the backswamp. (NSW DPI, 2005).*

A water quality monitoring program at Haughwood Canal undertaken by NSW Agriculture during 2003 and 2004, captured conditions whilst the floodgates were actively managed. Monitoring showed the benefit of tidal flushing, with the pH of drain water near the floodgate 2 to 3 units higher than the pH of drain water in the former backswamp area (NSW DPI, 2005). The pH of drain water in the former backswamp area in 2003 and 2004 ranged from 2.7 and 4 (NSW DPI, 2005). Tidal exchange has diluted acidity within the drainage system before it enters Bungawalbyn Creek.

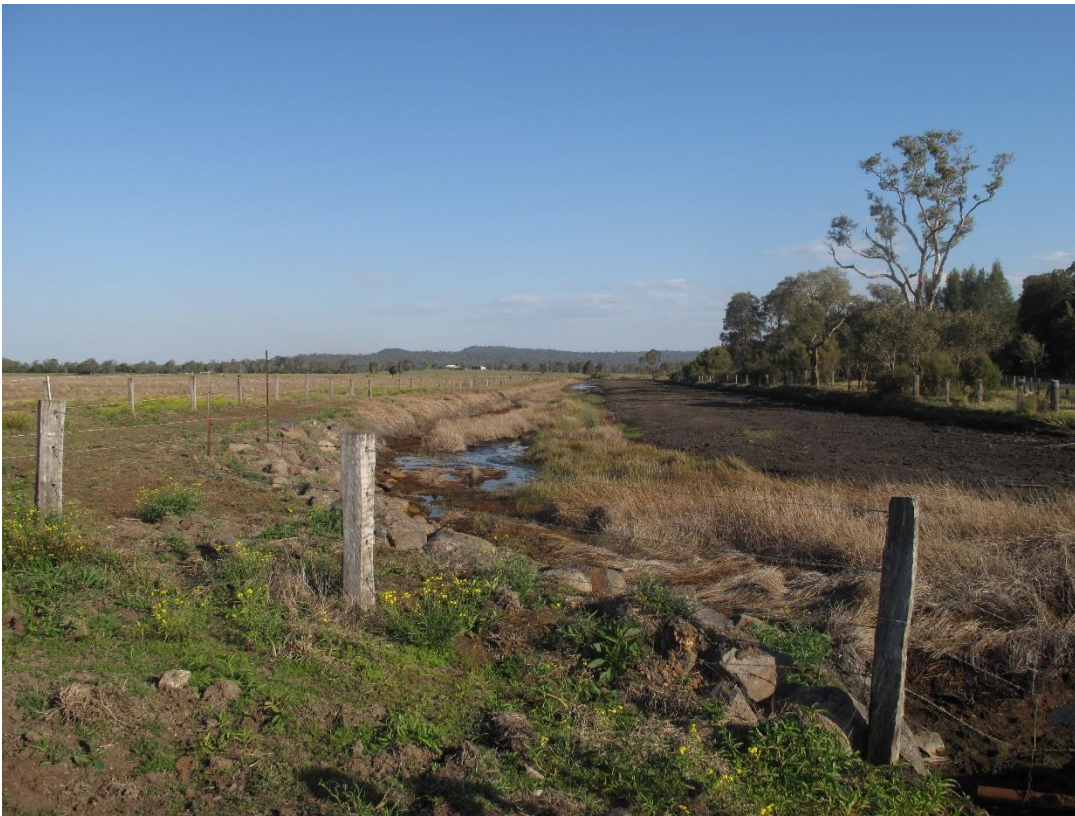
*5: Looking downstream along the eastern half of the drainage system in 2010, after the drain was reshaped to be not as wide or deep.*

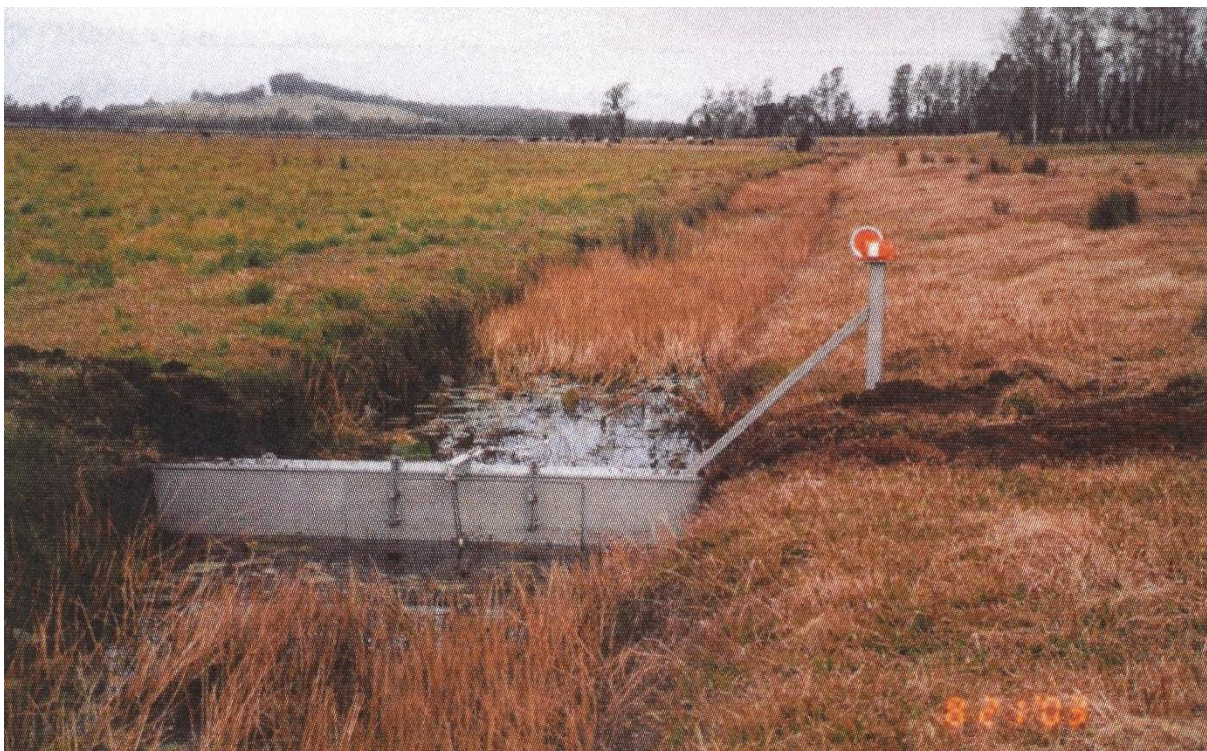
*7: One of the groundwater containment weirs that was installed in the private section of Haughwood drainage system in 2003.*

In 2003, NSW Agriculture installed two groundwater containment weirs in the privately owned, western half of the drainage system.

During the reshaping, the groundwater containment weir furthest up the drainage system was removed. The first weir near the road was left but is now completely covered with vegetation and the drain has filled in so sediment sits above the structure crest.

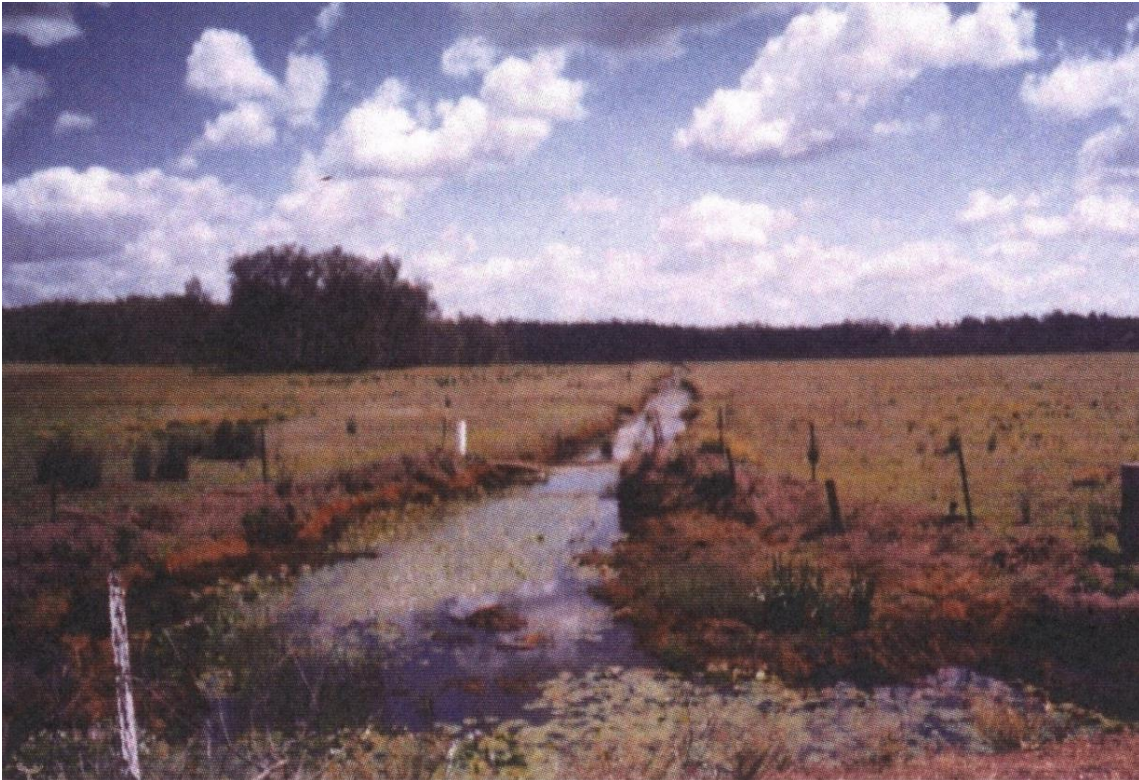
*8: Looking west, and upstream from Haughwood Road in February 2002.*

The change in vegetation can be seen in the series of photographs below. These are taken from Haughwood Road, which intersects the drainage system and separates the eastern and western halves.

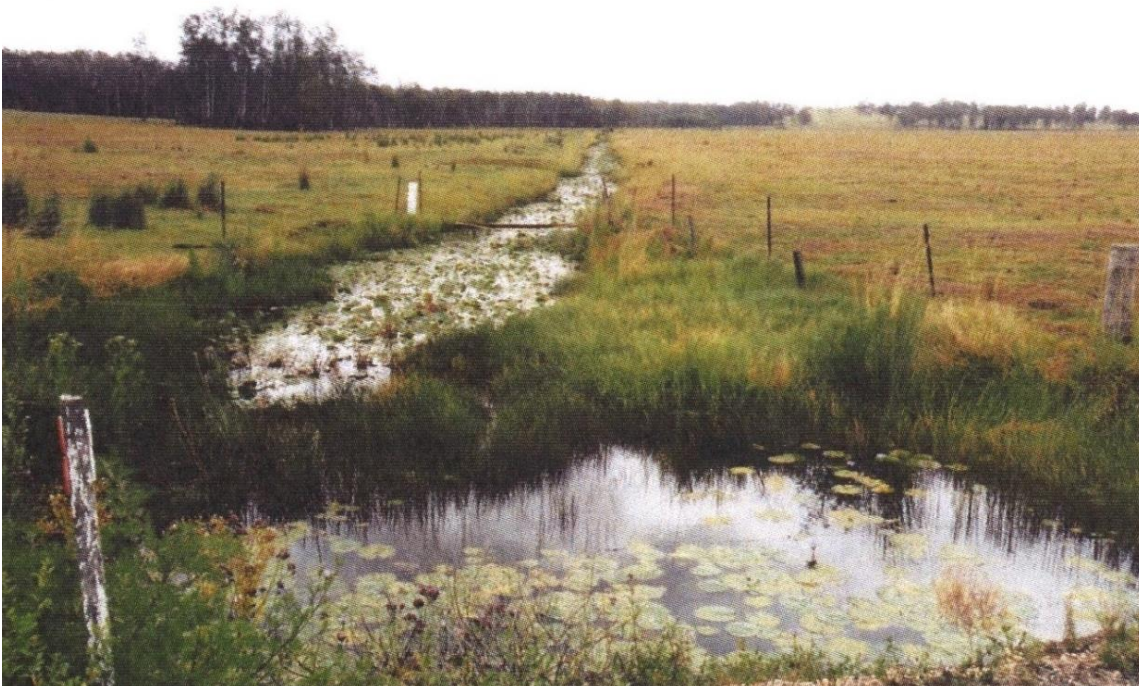
*9: Looking west, and upstream from Haughwood Road in January 2004. It was noted the Spring and Summer were wetter than the years previous.*

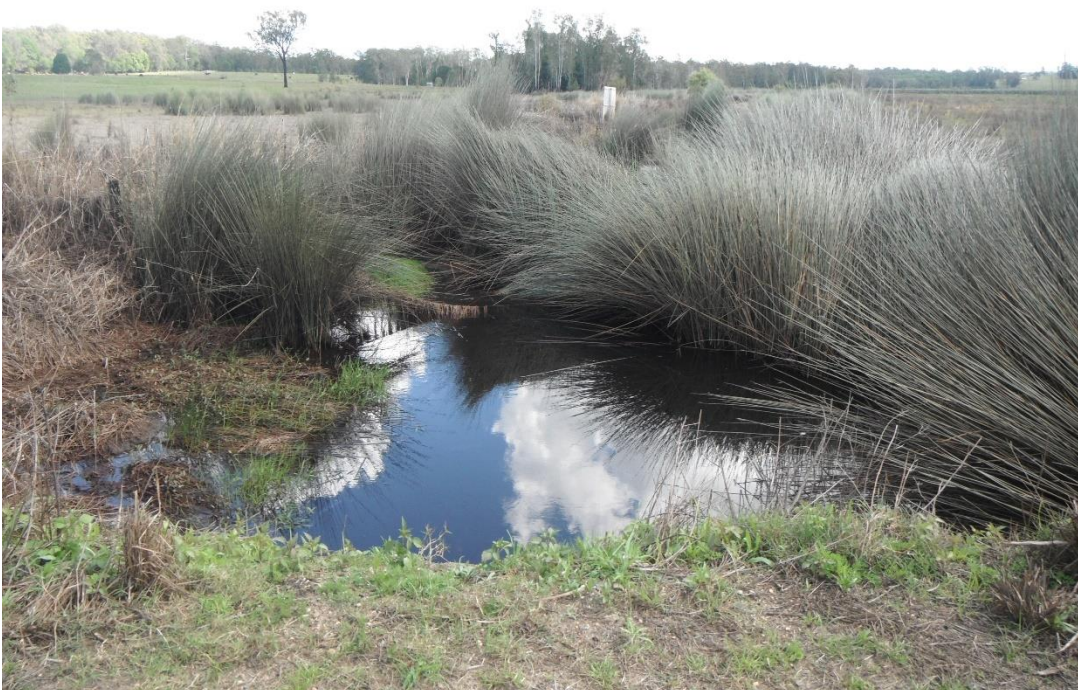
*10: Looking west, and upstream from Haughwood Road in 2013, note the thick stands of Grey Sedge along the drain.*

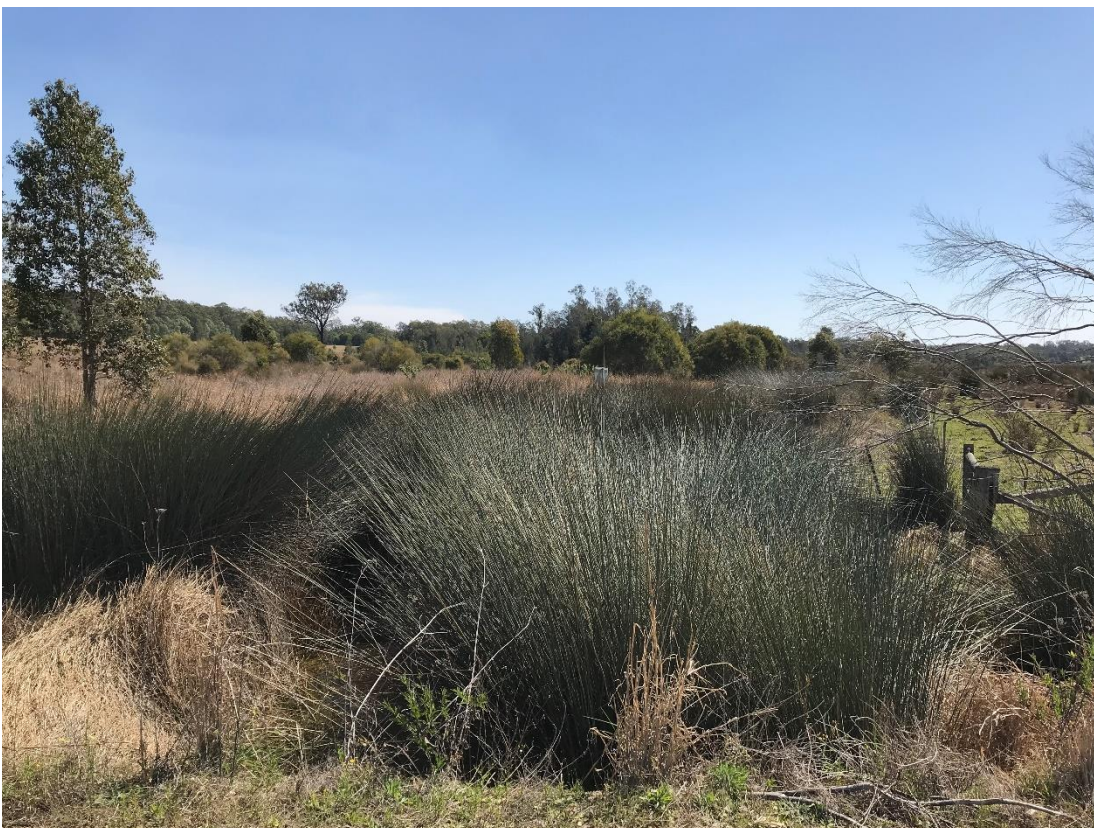
*11: Looking west, and upstream from Haughwood Road in 2019, the drainage system is now dominated by Grey Sedge.*

In 2019, much of the lowest lying backswamp area is now dominated by Grey Sedge. The Sedge is growing throughout the private drainage channel and is blocking flows. Another local species *Leptospermum brachyandrum*, a weeping tea tree, has also colonised the lowest lying areas.
